# CONSERVATION OF MURAL PAINTINGS IN SECULAR BUILDINGS IN SLOVENIA

*Blaž Šeme*

*Tjaša Pristov*

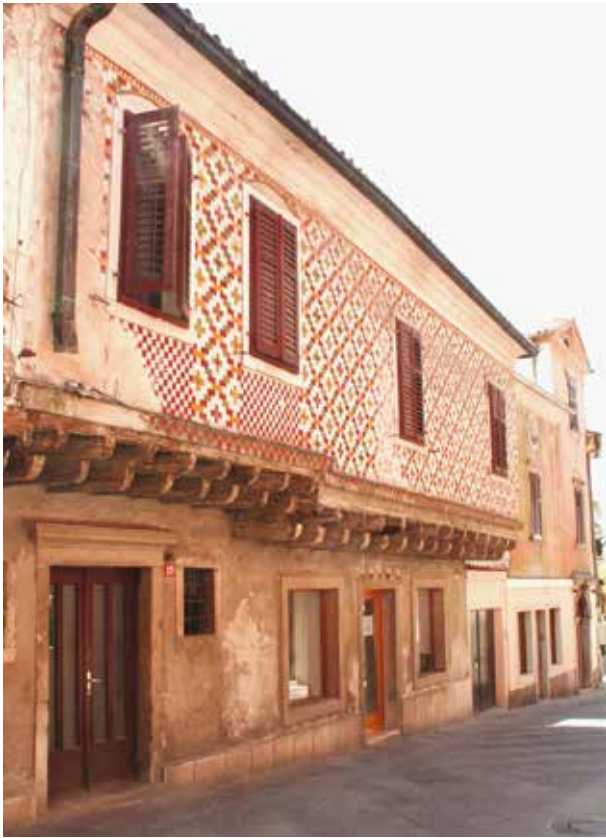
3. Painted façade of a house on Kidrič street in Koper,  
photo by Blaž Šeme, 2007

preserving these paintings on façades is very difficult because of direct exposure to harmful atmospheric factors [ill. 3]. The important segment of medieval and Renaissance mural painting in Slovenia is mainly well conserved-restored paintings of urban houses and palaces, e.g., in Celje (Glavni trg 8), Kranj (Pavšlar's House), Škofja Loka (Homan's House), Koper (Cankarjeva 2, Tovarniška 2, Kreljeva 6), Laško (parish house), and Krško (Mencinger's House).

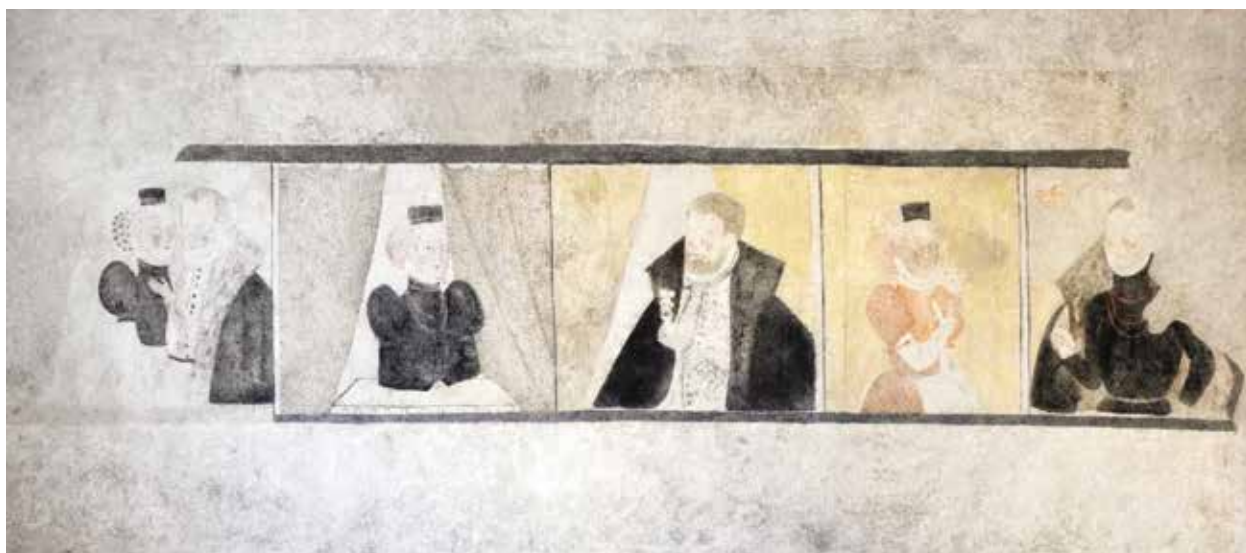
4. Series of Renaissance portraits discovered during the renovation of Mencinger's house, photo by Tjaša Pristov, 2013

that several living quarters were fully decorated. Wholly preserved decorative paintings, probably made in the late nineteenth century, were made with stencils. Rich ornaments on the walls with decorative lines and a rosette in the middle of the ceiling fully cover the walls in the rooms like wallpaper. While uncovering these paintings in one of the rooms, the restorers came across another, even earlier wall painting. A line of male and female portraits was hidden under two layers of thick plaster. Chief conservator of the project Alenka Železnik from the Institute for the Protection of Cultural Heritage of Slovenia, Ljubljana Regional Office, dated the portraits back to the second half of the sixteenth century, referring to the clothing typical of the period of Protestantism. At that time, Protestantism was widespread in Slovenia and the city of Krško was a strong Protestant centre, so the portraits may have depicted some nobles who lived at that time. Among the portraits, two coats of arms were painted on a base; there is hope that in the future it will be possible to identify the members of the noble family portrayed on that base. The uncovered Renaissance paintings represent a unique find of utmost importance in the Slovene region. Portraits were painted very delicately and, despite a very limited range of colours, the hairstyles and clothing details are well visible [ill. 4].

While restoring these paintings, a team of restorers were faced with alteration of pigments, which had started to fade. It is not really clear what caused the fading of the pigments, but it is assumed that an improper method or agent for surface cleaning was used, or a method was improperly executed. It is important that the use of different chemicals for treating wall paintings requires advanced knowledge

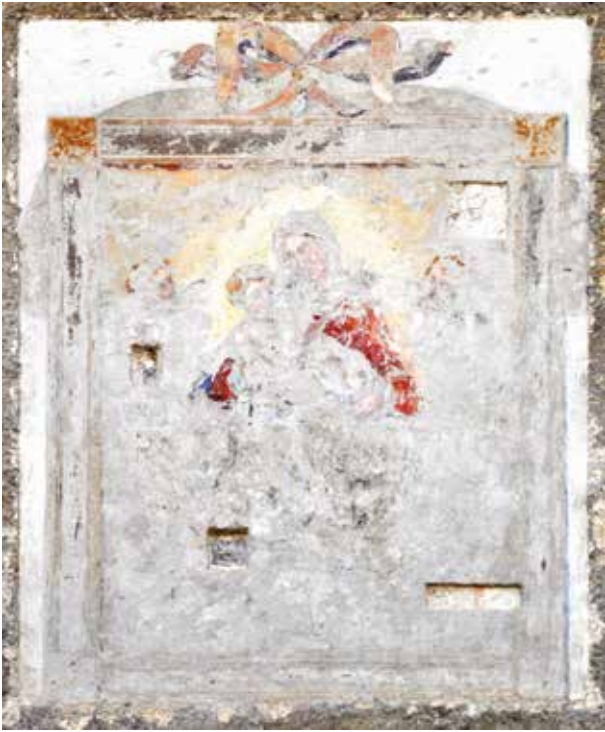
5. Uncovered original mural of *St. Mary Help of Christians* discovered on the façade of Mencinger's house, photo by Tjaša Pristov, 2012

eighteenth and nineteenth centuries. While the fresco was in a very poor condition, completely destroyed in the lower part, it was decided that it had to be demounted from the façade, fixed on a new portable support and displayed in a secure environment, away from any harmful weather conditions that could cause further deterioration. However, a new approach was chosen for the creation and reintegration of a copy of the original fresco on the façade. Instead of making a new copy by classical painting technique on plaster, reconstruction was made by digital technology on a vapour-permeable foil Transfer, a medium that is capable of producing a large number of replicas. A slightly more advanced approach is already established abroad, while in Slovenia it was the first example of the kind. All the necessary data for the reintegration of the missing parts of the original portrait were collected by historical research and individual studies of analogues. The original painting was precisely photographed. The photos were taken in the digital RAW format, processed with Adobe Camera Raw computer tool, and colour calibrated

with the Colour Checker Passport computer program. Based on the original photos and collected analogues, the full drawing of the image was made with the computer program Calera Painter. For a reintegration test, a section of the processed image was printed and applied on a new surface of a smaller dimension, where special attention was paid to the precise colour tone and its intensity. Due to the use of multiple media in designing the reconstruction, various deviations in colour could occur. It was necessary to ensure the best possible matching of the colours on print with the colours on the original. After adjusting the colours and finishing the individual details of the image, the reconstruction was ready for print. The image was printed on a vapour permeable, highly elastic film, which was applied to a new plaster. Finally, the surface was coated with varnish, which gave the image its final look (a slightly matt appearance) and additional surface protection. Since the reconstruction was performed, regular inspections have been carried out and no deteriorations have been detected (until now). The reconstruction was highly esteemed from the viewpoint of appearance and technological implementation. The viewers who are not familiar with the used technology actually are not aware that the image is applied like wallpaper and not painted. The demounted original painting was reintegrated on a new support and is now displayed in a memorial room beside the uncovered Renaissance portraits. Initially, these two rooms were meant for the offices of the Faculty of Energy, but due to the discovery of Renaissance portraits the intended use of the space was changed. Leading design engineers, representatives of the Institute for the Protection of Cultural Heritage of Slovenia and representatives of the Municipality of Krško acclaimed the value and the quality of these discoveries. The offices were converted into museum rooms where the life and work of Slovene writer Janez Mencinger is presented. The rooms are opened to the public and serve as a foundation for further research into the city's history [ills. 5 and 6].

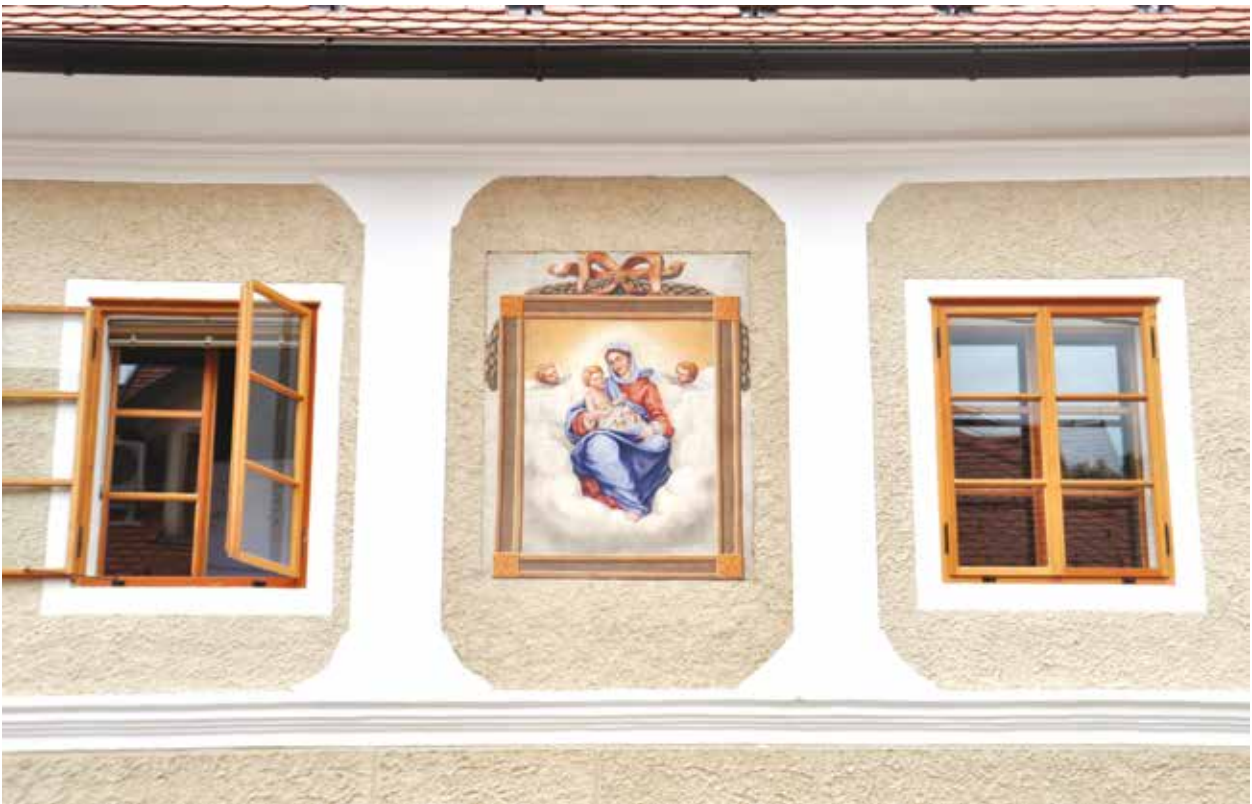
6. Reconstructed mural of *St. Mary Help of Christians* applied as wallpaper on the renovated façade, photo by Tjaša Pristov, 2013

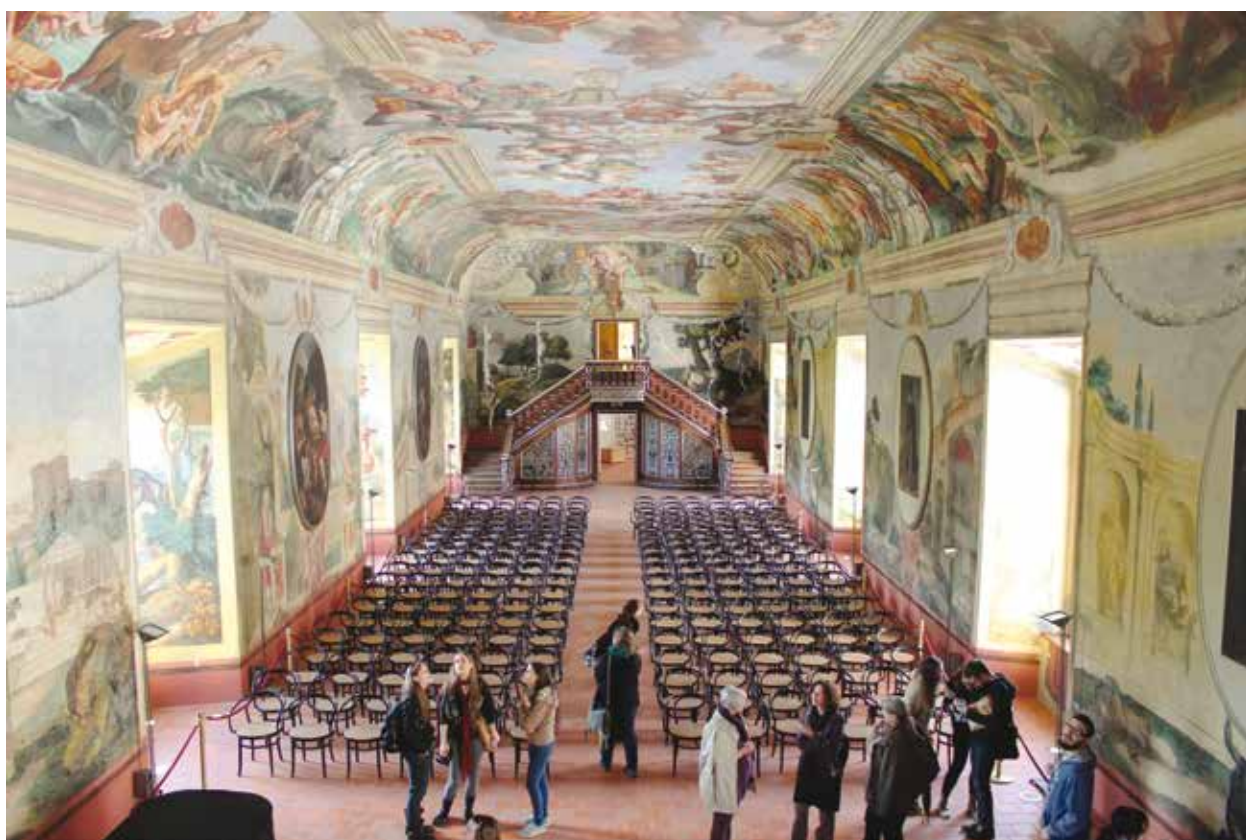
8. Baroque paintings in the Hall of Knights in Brežice castle after conservation-restoration of the ceiling, photo by Blaž Šeme, 2014

manor) were also among the largest and most complex conservation-restoration projects of mural paintings of the last decade in Slovenia [ill. 8]. The projects were supervised by experts from the Restoration Centre of the Institute for the Protection of Cultural Heritage of Slovenia. It is also very useful for the students of conservation-restoration at the Academy of Fine Arts and Design who had the opportunity to work on sites during the conservation-restoration practice, e.g. on baroque mural paintings in manor houses in Smlednik, Vipava, Gracarjev turn and Tuštanj [ill. 9]. It should be noted that especially in the north-western part of Slovenia there are many baroque paintings in peasant houses, which was part of the tradition of decorating the façades of towns and villages in the

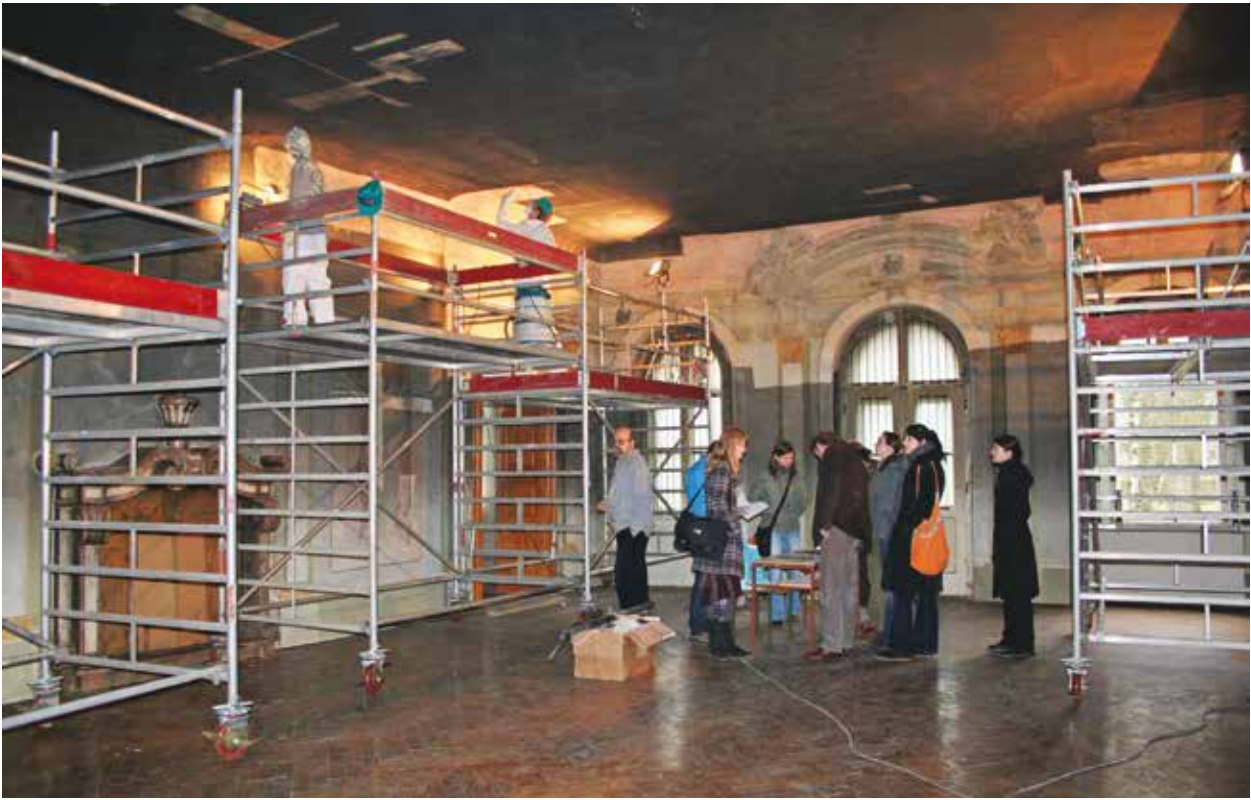
9. Baroque paintings of the Hall of Knights in Smlednik (Valburga) manor during conservation-restoration, photo by Blaž Šeme, 2007

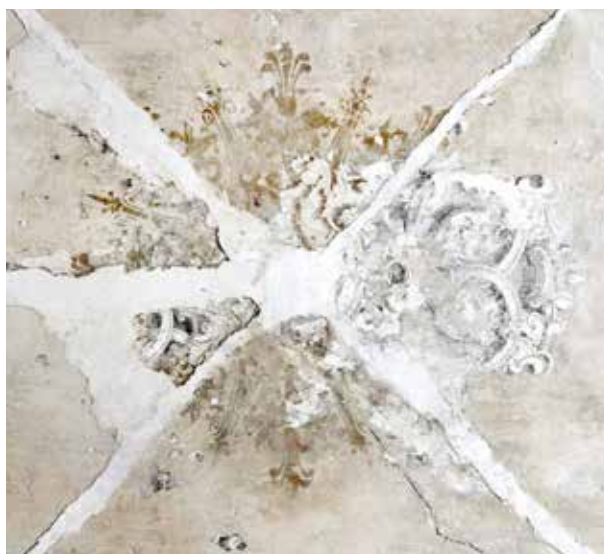
10. Central part of the ceiling in the palace at Novi trg 4 during the uncovering and documenting of several painted layers, photo by Tjaša Pristov, 2011

the baroque palace. The mural was restored using the principle of mimetic reintegration. Two more painted layers under this painting were left intact.<sup>13</sup> In the case of several painted layers, dilemmas of their presentation occur, because one or more painted layers are destroyed. Since the method of demounting wall paintings is not developed to an extent that it could insure the detachment of one painted layer from another, the decision ‘which one’ will be sacrificed has to be made. It has been done, but the technology is very complicated. Decisions are normally taken on the basis of object investigations, the entire visual identity of the building, the function of the space and available resources.

During one of the most recent stratigraphic researches in the house at Mestni trg 10 built in the style of early Baroque, a bourgeois palace with an arcaded courtyard, a baroque staircase and a rococo façade situated in the old town of Ljubljana, more than sixty decorative wall patterns were discovered. Some of them were in extremely poor condition, preserved only in fragments. Better preserved patterns (approximately forty samples) were uncovered only partially to the extent of their repetition, so that a drawing of the pattern could be made in scale 1:1 and prepared for further graphic processing. Vector drawings were made and graphic reconstructions were designed for selected individual samples with the aim to present to individual owners of private apartments an overview how the wall paintings would look when restored. With this approach the Institute for the Protection of Cultural Heritage of Slovenia seeks to encourage the owners to consider the possibility of presenting discovered paintings. Since the renovation of the building is ongoing, the ultimate fate of the murals is still unknown. These examples reveal how richly noble houses were decorated in the past [ills. 10 and 11].

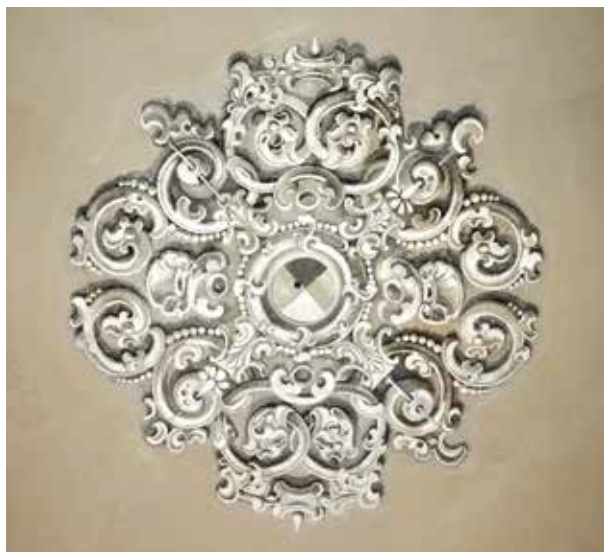
11. Central rosette on the ceiling in the palace at Novi trg 4 after completion of conservation-restoration works, photo by Tjaša Pristov, 2011

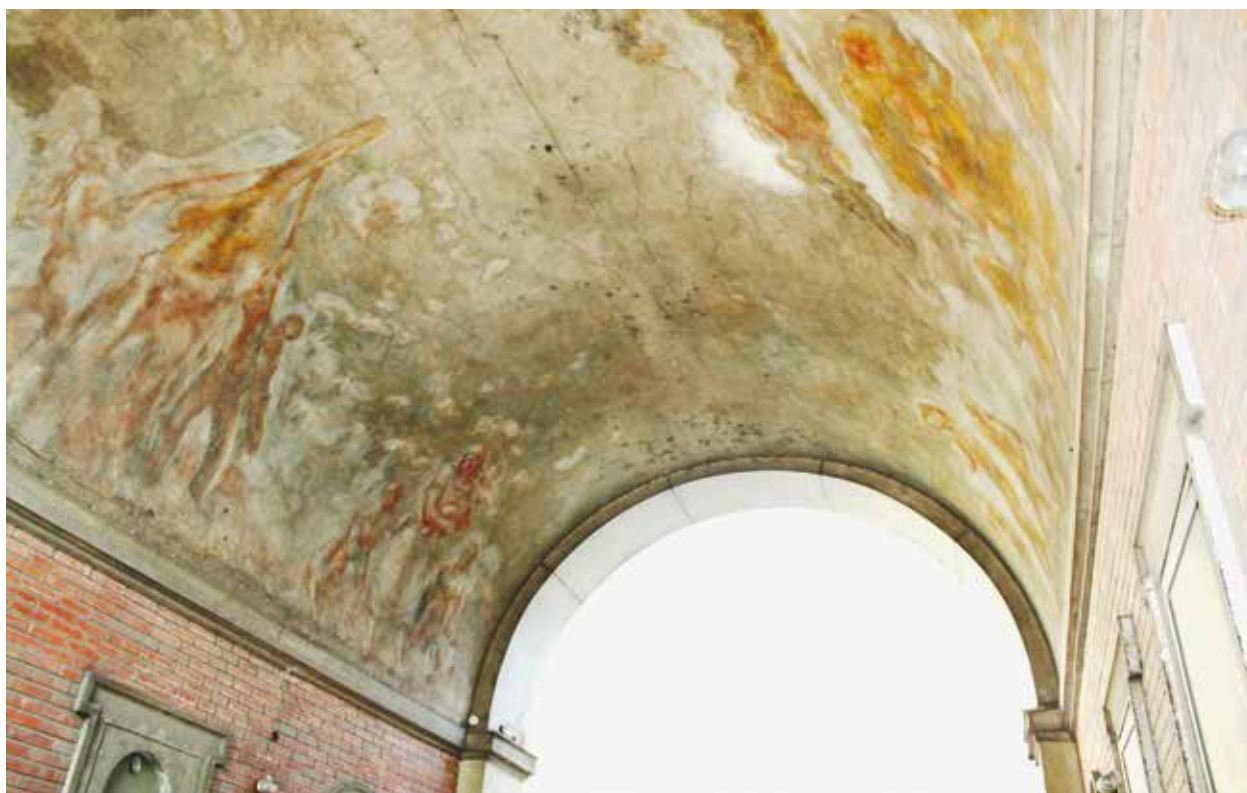
12. Entrance hall of the Meksika building at Njegoševa 6 with paintings by Rihard Jakopič, photo by Blaž Šeme, 2007

Mural painting of the first half of the twentieth century in Slovenia has not yet been well researched. Beside several painters who definitely worked in secular buildings, e.g. Matej Sternen (1870–1949), Ivan Vavpotič (1877–1943), Helena Vurnik (1882–1962) and France Kralj (1895–1965), an interesting and probably the only mural painting by the best-known Slovenian impressionist painter Rihard Jakopič (1869–1943) should be mentioned. The painting, which is located on the Meksika building on Njegoševa cesta in Ljubljana, is rather large. The challenge to properly preserve and conserve-restore this painting is huge because of the inadequate technique of execution; besides, being on the exterior of the building, it is exposed to air pollution and other harmful atmospheric factors [ill. 12].

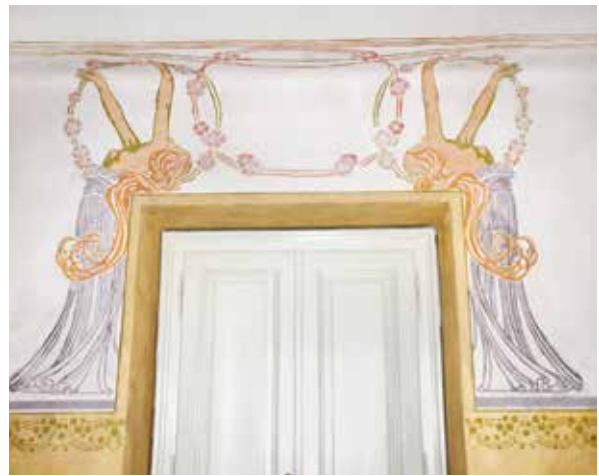
13. Art nouveau painting in Villa Poljanska 97 after restoration interventions, photo by Tjaša Pristov, 2014

A distinct example is a partly represented art nouveau painting discovered in Vila Poljanska 97, in Ljubljana [ill. 13]. Despite the lack of resources and due to functional modifications required by the modern standards of renovation of public spaces (buildings), it was possible to preserve the paintings in one room and part of the corridor. All the corridors and the staircase were originally decorated with a decorative painting in the art nouveau style. Uncovered wall paintings are characterized by stylized wreaths with vegetable ornaments and individual flowers between thin lines geometrically arranged along the walls of

the focal point, with additional decorative bands at the top and the bottom of the wall. Individual preserved components revealed a fully decorated room on the first floor, which is also adorned with elegant, curvy shapes. Six equally stylized female figures fill the areas around the door openings. Although the figures were made with stencils, they create a sense of eroticism and sensuality. Women figures are painted in an easy and relaxed poise, and their dresses and thick orange hair blend into a pattern. In their hands they hold a floral wreath, a motif that is repeated in the centre of the ceiling. In the lower part of the walls, the painting ends with a playful ornamental belt from symmetricaly arranged circles and individual lines. All the discovered paintings were in an extremely poor condition, mainly due to previous construction and installation interventions. By restoration interventions the original parts of the paintings were mimetically integrated, while the missing and badly deteriorated parts were reconstructed. The project was successful because the investor, the Municipality of Ljubljana, showed the right amount of interest and understanding of the increased value of the villa due to the uncovered paintings. Such cases represent an exception rather

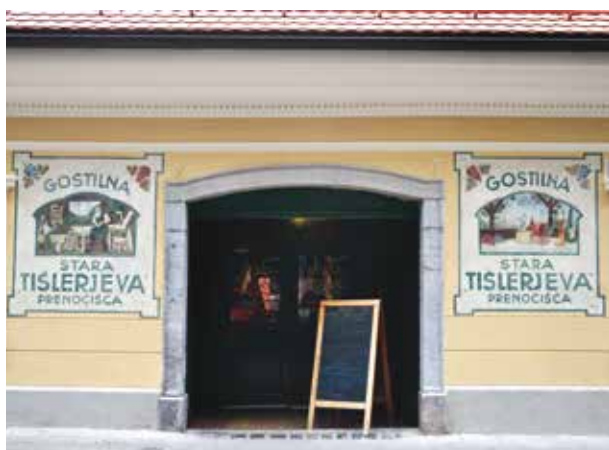
14. Paintings on the façade of Kolodvorska 8 – Old Carpenters Restaurant – after completed restoration interventions, photo by Tjaša Pristov, 2012  
Pastato Kolodvorska g. 8 – Senojo dailidžiu restorano – fasado tapyba po restauracijos

In the case of renovation of the façade on Kolodvorska 8, a 150-year-old guesthouse in Ljubljana, the owners were thrilled when advertising signs with decorative paintings were discovered. Some of the discovered signs were captured in an old photograph of the house from 1935. The signs were in a very bad condition. In the past, two of the uncovered signs advertised the sale of beer and vine. Sadly, due to the lack of finances and data for proper reconstruction, these two paintings were not exposed. They were thoroughly documented. This decision resulted from the fact that even more interesting paintings were uncovered on both sides of the front door. A sign 'Restaurant, Old Carpenter Hostelry' with a carpenter painted in his workshop was uncovered on the right side of the door. The sign was repeated on the left side of the door, where the central field was decorated with a scene of still life. Both signs were painted in oil, and the paint layer was full of craquelures. Some parts of the paintings were seriously damaged because of later electric installation and previous renovations of the façade. Recent layers were removed mechanically and chemically until the paintings were fully cleaned. All lacunas were filled

with lime mortar and the missing parts of colour were locally retouched. Having finished the façade renovation and painting restoration, the owners mentioned the new findings in their accommodation offers. The visitors and guests, especially those from abroad, appreciate the atmosphere of this old inn [ill. 14].
