THE STORY OF A WALL PAINTING

Heli Tuksam

TARTU ART COLLEGE

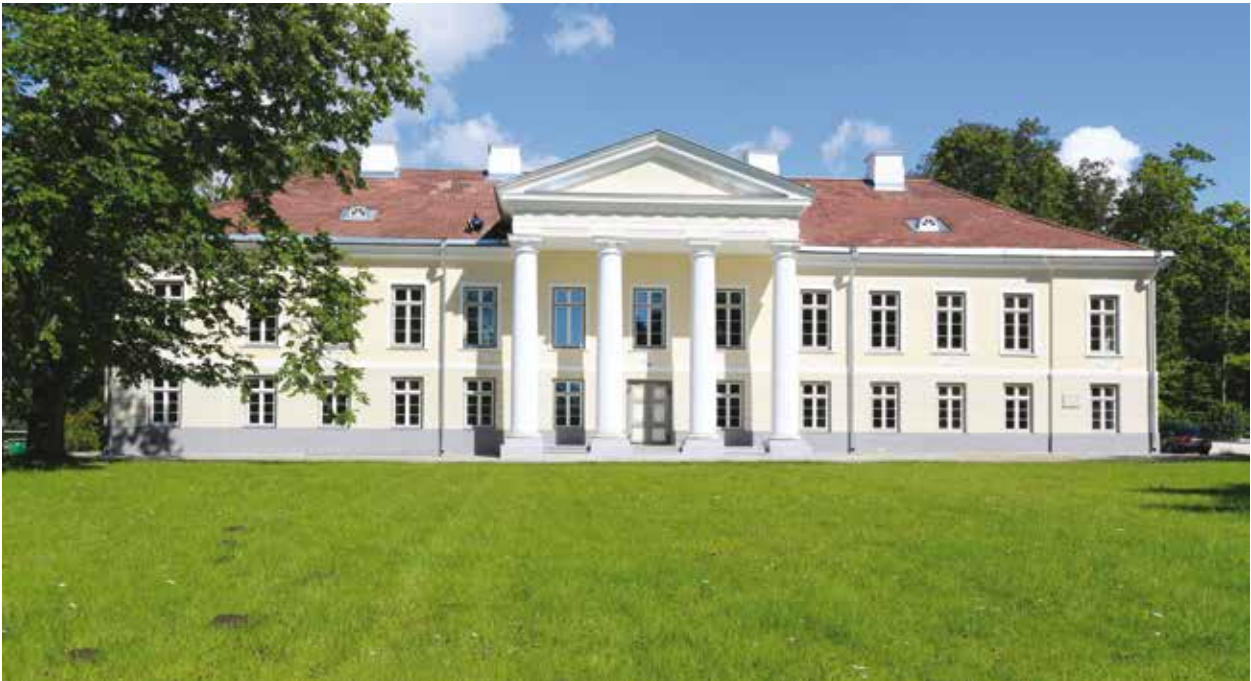
1. Aruküla manor house, photo by Heli Tuksam, 2015
Arukiulos dvaro rūmai
2. Aruküla manor in 1910, photo by M. Öömann,
J. Vali's private collection, 1910
Arukiulos dvaro rūmai 1910 m.

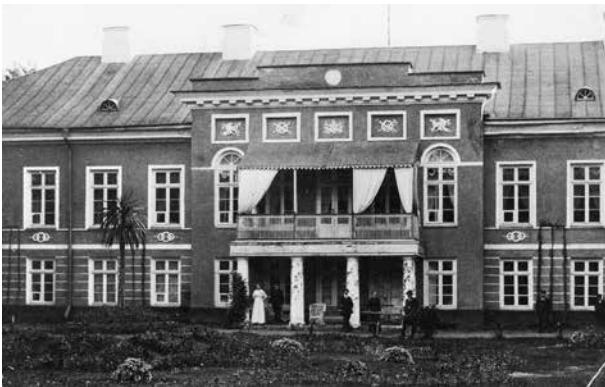
that extensive repair works began.² During the reconstructions, the building received a beautiful classicist appearance with magnificent stucco décor [ill. 2].

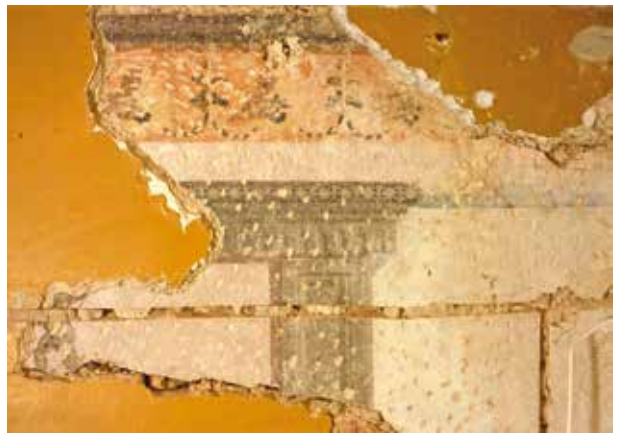
It was believed that not much of the interior decorations from the golden days of the manor had survived. However, during the construction works, when further research was conducted, it was unexpectedly discovered that there was a finishing from these days under a posterior layer of plaster and, moreover, spectacular painted compositions had been preserved under a thick layer of plaster in three rooms! [ill. 3]

3. Founded coating, photo by Villu Pink, 2014
Gruntas

The paintings were demounted from plaster by the restorers *H&M Restuudio OÜ* in 2015. Although

these were mere fragments with holes, the preserved pieces confirm that originally they were high-quality paintings.³

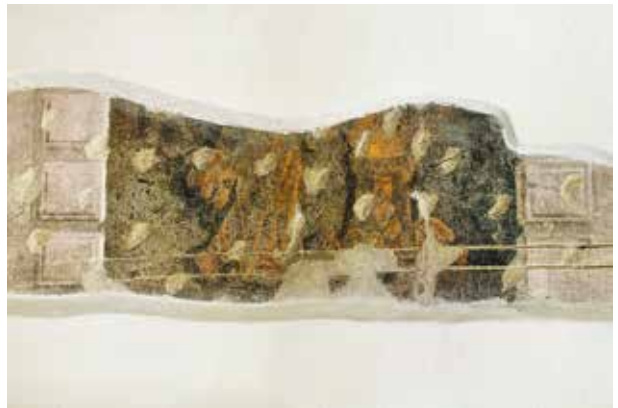
These paintings were compositions that highlighted the magnificence of the rooms and emphasised the doorways and the windows. Based on the fragments found in two rooms, it is possible to presume that there may have been imposing pillars around the windows and doors that culminated in figurative paintings above the doors. The fragmentarily preserved paintings in both rooms were inspired by the legacy of classical antiquity – it seems that one painting depicts a figure in Etruscan red and black colours holding an amphora-type container (vessel) [ill. 4]. Another painting shows a boy with wings and a spear similar to Cupid.

4. A figure, photo by Villu Pink, 2014
Figūra

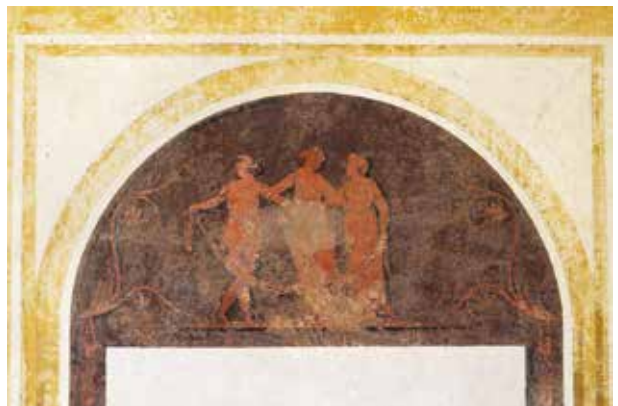
5. Similar figures in Kiltsi manor house, photo by Heli Tuksam, 2015
Panašios figūros Kiltsi dvare

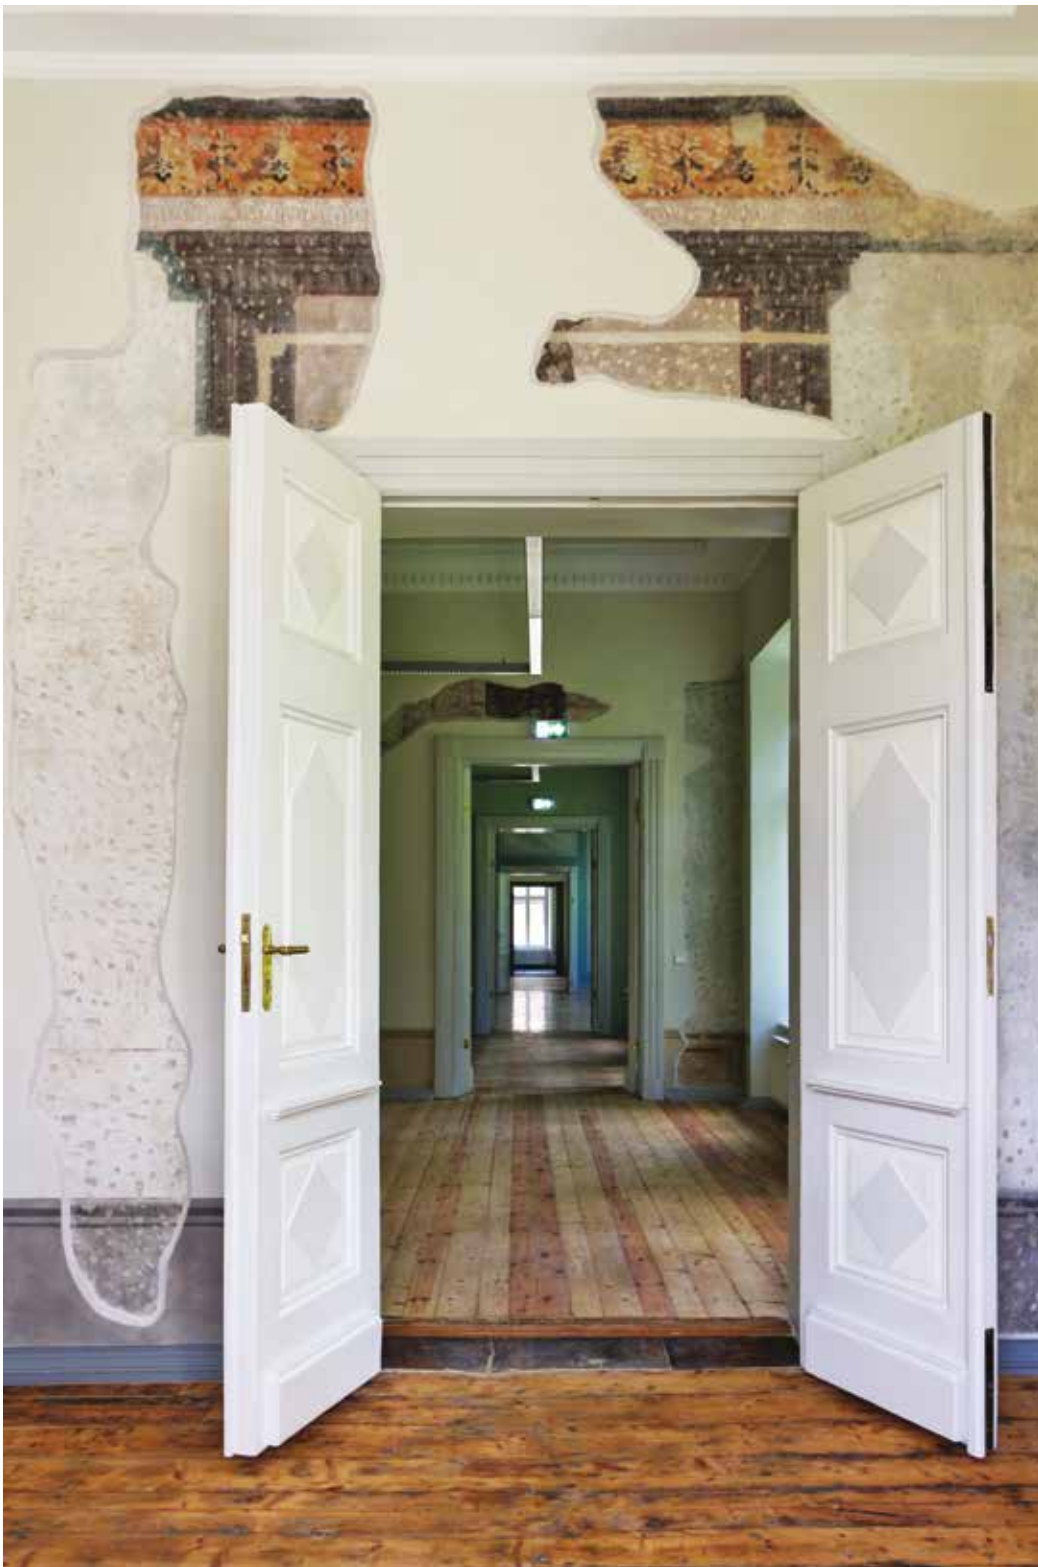
Enfilade doorways in Aruküla run into stocky painted pillars. Besides, the painted surfaces above the doors are not in the centre of the doors – it is thought that the doors were moved in relation to their original classicist-style position during the reconstruction works in the beginning of the twentieth century [ill. 6].

6. Enfilade doorways in Aruküla, photo by Heli Tuksam, 2015

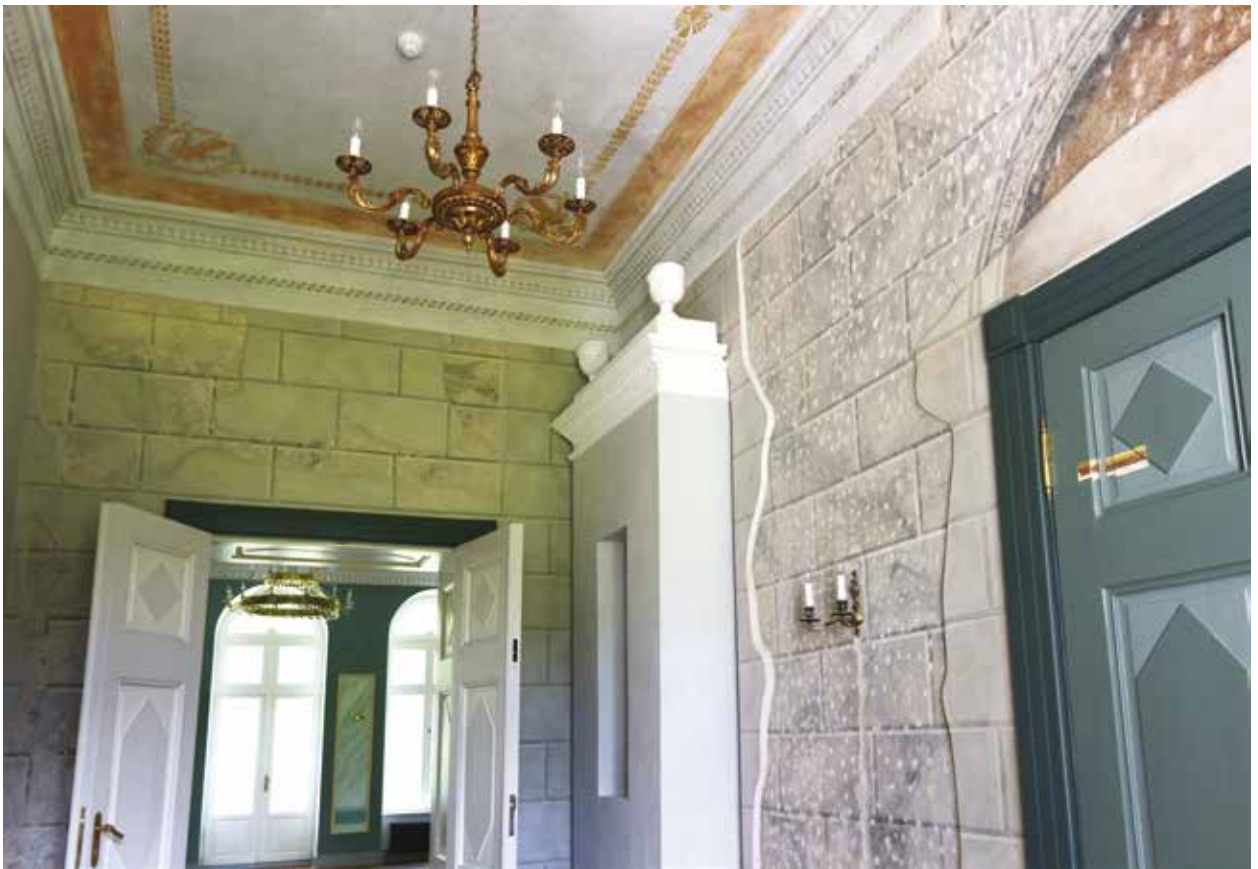
7. Classical paintings in the lobby, photo by Heli Tuksam, 2015

as it helps to explain the room planning – the vestibule and the small room leading to the hall may have originally constituted one big room, and the partition wall between these two rooms was added later. At the same time, the room with earlier paintings was plastered; a cavetto vault and a new classical ceiling painting that is also a finely modelled ornament were added [ill. 7].

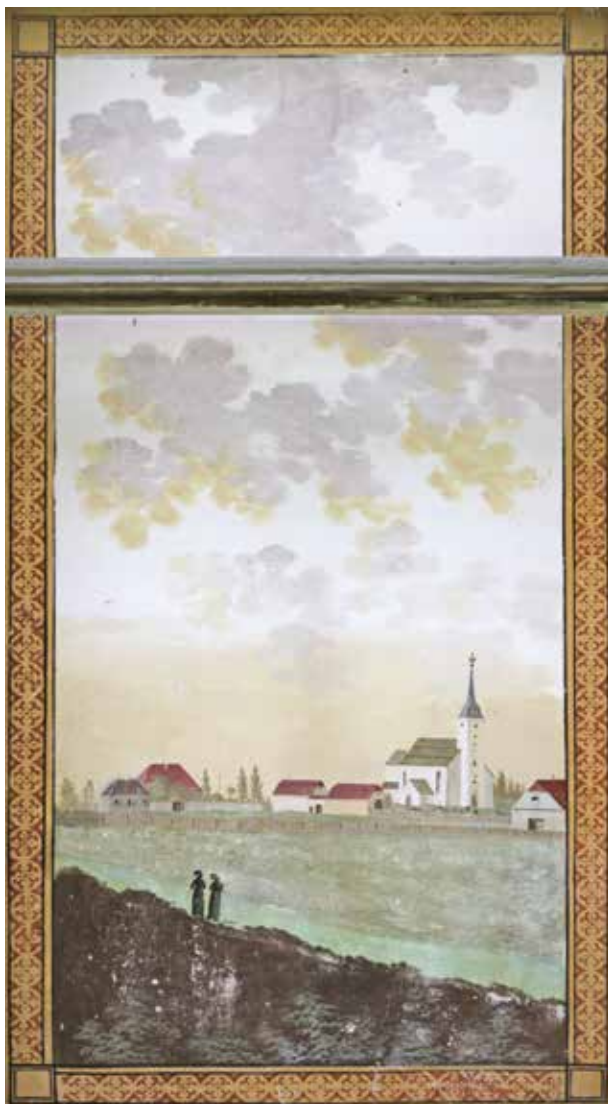
one of the two windows is still in a very good condition. The other window is almost destroyed. On the well-preserved window we can see a view of the Koeru church. The chapels depicted in the picture were already destroyed by the middle of the nineteenth century. Therefore, the well-known Estonian art historian Villem Raam suggests that it may have been painted in 1838–1840 [ill. 8].⁴

8. View to Koeru church, photo by Heli Tuksam, 2014

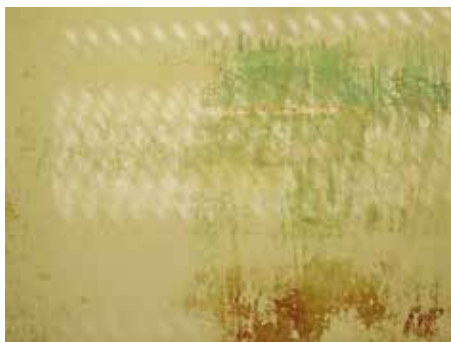
9. Deteriorated painting, photo by Heli Tuksam, 2014

possible to take a closer look at the paintings. The aim of the visual observation was, first of all, to determine the condition of the largely deteriorated painting. The main reason for the damage was a broken window-pane, through which rainwater had been entering and destroying most of the painting [ill. 9]. With the help of a single preserved painting fragment it was possible to distinguish some figures. Observation showed that it was a landscape painting with two recognisable objects in the background. In the background, near the forest, it was possible to see a yellow building of grandiose measurements, which could be recognised as the main building of Aruküla manor. On the left side of the painting, the roof and the wings of the building could be seen. On the road that ran from the lower right side to the upper left side, there was a barely recognisable shape of a rider. Based on the description one could say that these two paintings were practically painted from the same place looking in different directions: one towards the church, and the other towards the manor house. This becomes clear from the conversations with the locals and historical pictures, which clearly show that the old windmill was located somewhere on the present site of the municipal hall. An old photo with a view of the south-eastern frontal wall of the manor house was also found. In the picture, one can see a landscape and different light-dark colours [ill. 10]. The ground layer of the painting was damaged and had several dense holes, several traces of flow-downs and a larger area of damaged finishing in the middle part.

Only the surrounding strip of the ornament, the greater part of the sky, a forest depicted on the right side, part of the central shrubs, fragments of a windmill and several fragments of a rider had been preserved. The preserved pieces of single colour still gave some hope for a possibility to restore the painting to some extent.

The first task in the restoration of the paintings in the window niche was to conduct a background research and laboratory examination to determine the adhesive and the pigments. Samples were taken from the ornamental strip of the damaged window and the green colour of the landscape to determine the pigment.

The conception and objective of the restoration was to expose the original as much as possible. The first task was to conserve the preserved parts, and the second, to highlight the aesthetic whole through retouching, while avoiding retouching any parts without proof.

- The first task was to fix the original according to the action plan. The colour separated from the

part of the ornament was infected with the substance *Medium für Konsolidierung*. Part of the painting was fixed with *paraloid B72* in acetone (5–7%).

- Plaster losses were filled with lime-sand plaster and smoothed over with finer lime-marble filler.
- The surface necessary for retouching was undercoated with casein cover.
- Retouching was done with the planned casein paint. The reason behind this choice was that the new colour would not be stronger than the material used in the original. Since the lab results did not answer the question whether water glass was used as an adhesive, it was decided to use a more familiar adhesive.
- Retouching provided the general background that could be followed based on several

preserved colour fragments. It was not possible to restore the graphics in the parts where it was completely missing. The idea was to follow the same general impression as in the historical photo. The largest problem was the road with a rider. The original paint on the surface was completely destroyed. Therefore, the surface was covered with broken white paint to reduce the strong contrast and to highlight the preserved image of the rider.

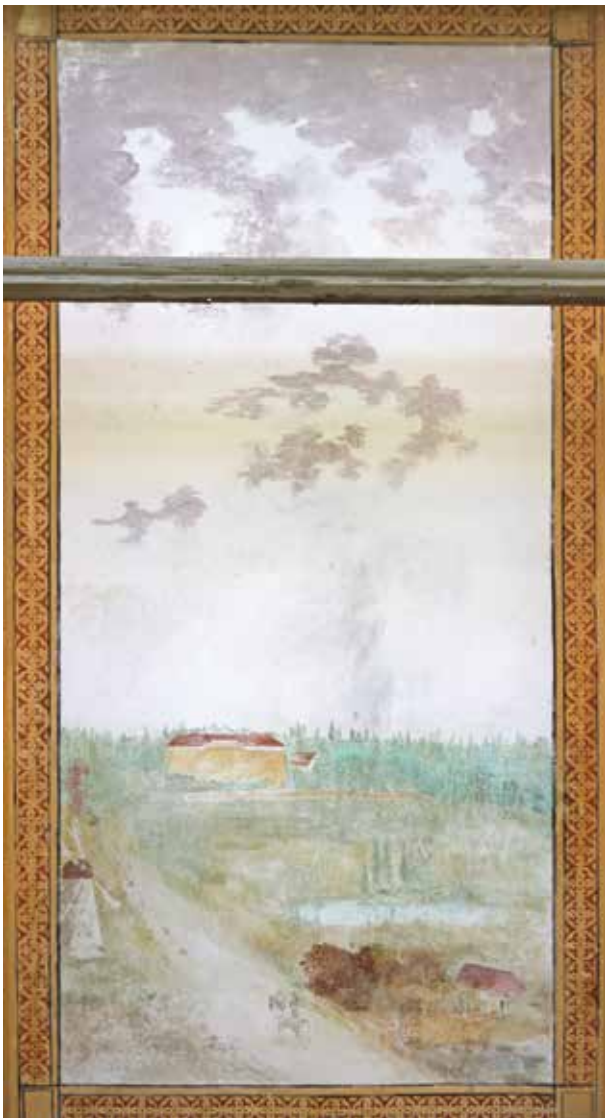
11. Retouched window, photo by Heli Tuksam, 2014

The main achievement could be the reappearance of the destroyed painting. Although the detailed painted graphics was not restored, the general composition and logic was recreated through a combination of readable colour remains. The main aim was achieved; the missing image appeared again. The discovery brought great pleasure to the local inhabitants, because no one could remember the existence of the destroyed painting.

- The missing ornamental parts were restored by stencil printing following the original.
- On the right of the well-preserved window, the pigment was lightly fixed only in the damaged parts. The plaster loss was filled with lime plaster and small colour damages were removed [ill. 11].
