CONSERVATION-RESTORATION WORKS ON WALL PAINTINGS IN SNG OPERA AND BALLET THEATRE LJUBLJANA

Tjaša Pristov

INSTITUTE FOR THE PROTECTION OF CULTURAL HERITAGE OF SLOVENIA,

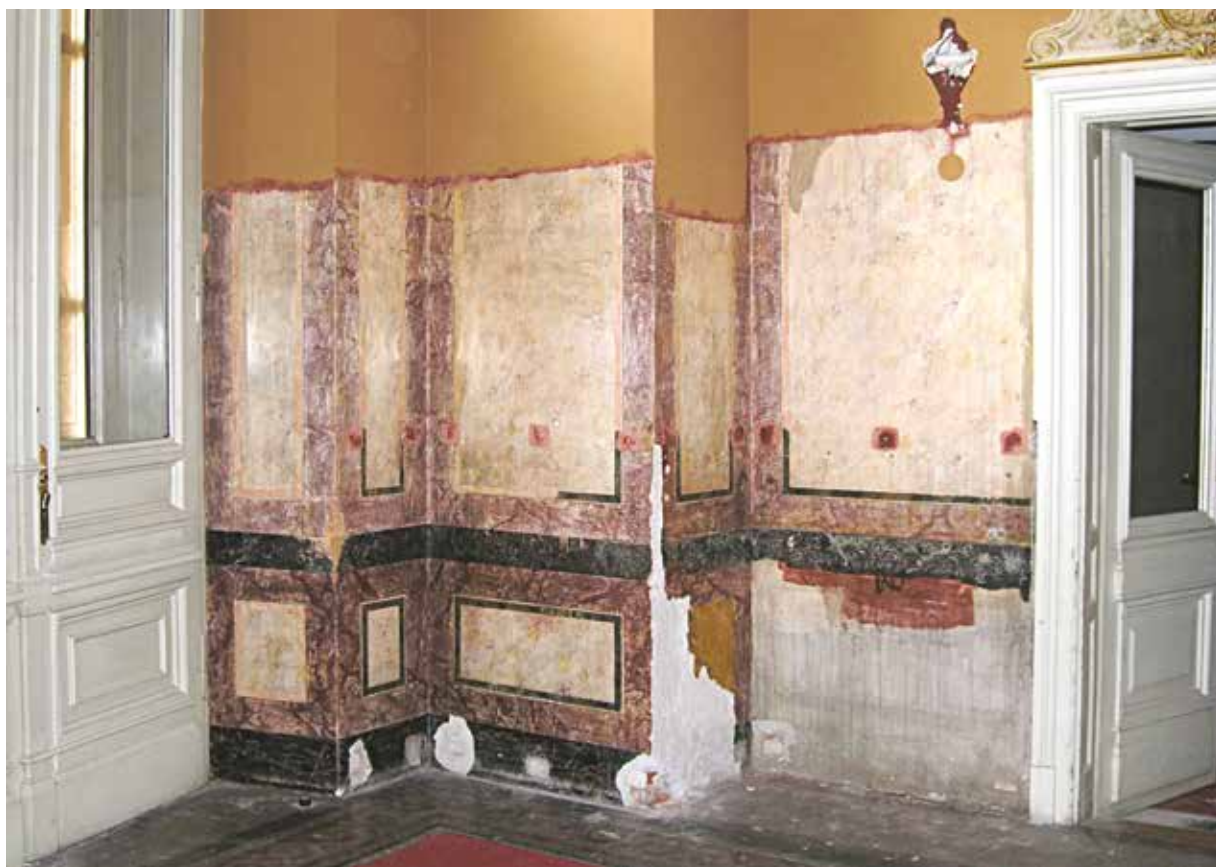
3. The uncovering of *stucco-lustro* on the southern wall of the foyer, photo by Tjaša Pristov, 2009

applying pigments on fresh plaster and polishing it with mineral wax as the main characteristic of the *stucco-lustro* technique [ill. 3].

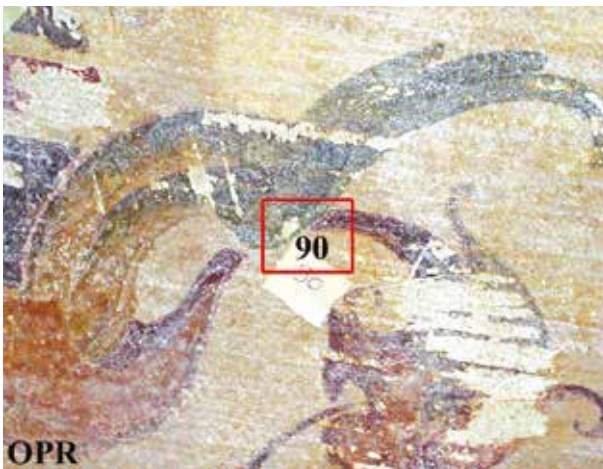
4. Sample OPR 90 taken from the second cassette on the ceiling in the lobby. Sample for the analysis was extracted from the green dragon wings. The colour was scratched from the surface
OPR 90 pavyzdys iš antros vestibulio lubų kasetės. Medžiaga analizei buvo paimta nuo žalių drakono sparnų. Spalva buvo nugremžta nuo paviršiaus

Research was carried out in order to determine the composition of the plaster, define the type of subsequent coatings, identify the binder in the plaster, analyse the composition of the insulating layer and identify the binder of the colour layers [ills. 4 and 5].

- The results for the yellow insulation layer (layer 1) of sample OPR 90 taken from the ceiling in the lobby showed a spectrum of elements: the presence of drying oil, calcium carbonate and aluminosilicate (kaolin).
- Analysis of the light green colour taken from the green dragon wings located on the second

cassette of the ceiling in the lobby (layer 3) showed the presence of drying oils, aluminosilicate (kaolin) and plaster.

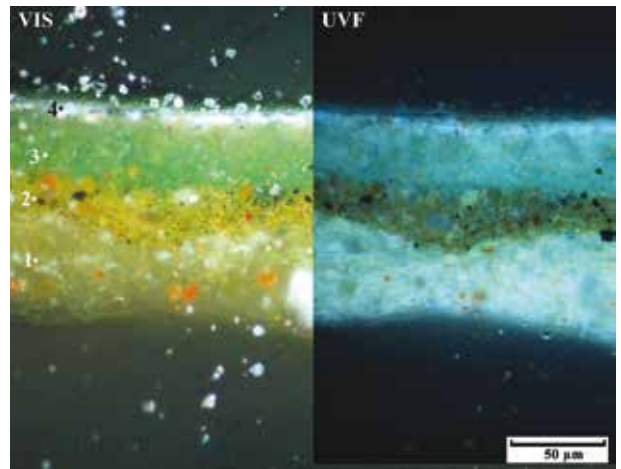
5. Sample OPR 90 shot under an optical microscope in visible and ultraviolet light. The layers in the cross section: 4 – white, 3 – light green (FTIR), 2 – ochre, 1 – yellow (FTIR)
OPR 90 pavyzdys po optiniu mikroskopu regimojoje ir ultravioletinėje šviesoje. Pjūvio sluoksniai: 4 – baltas, 3 – žalsvas (FTIR), 2 – ochrinis, 1 – geltonas (FTIR)

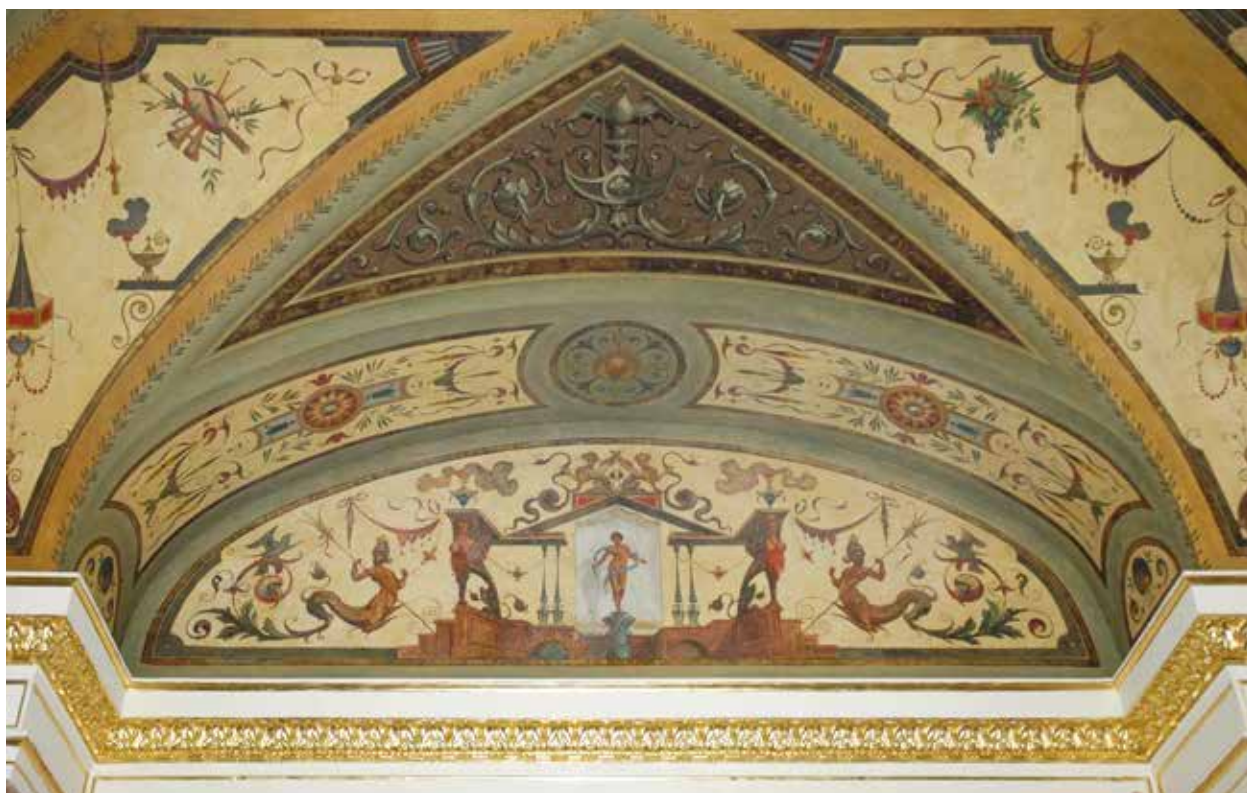
6. Uncovered paintings in the foyer imitate the Greek, Renaissance and, above all, Italian style of grotesque, photo by Tjaša Pristov, 2011

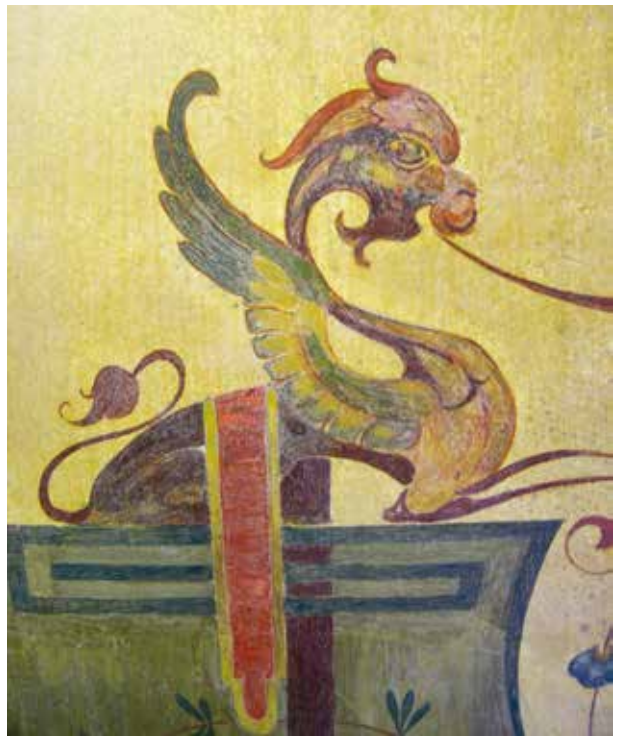
7. Detail of the painting discovered on the ceiling cassette shows the metamorphosis of mythological creatures, photo by Tjaša Pristov, 2010

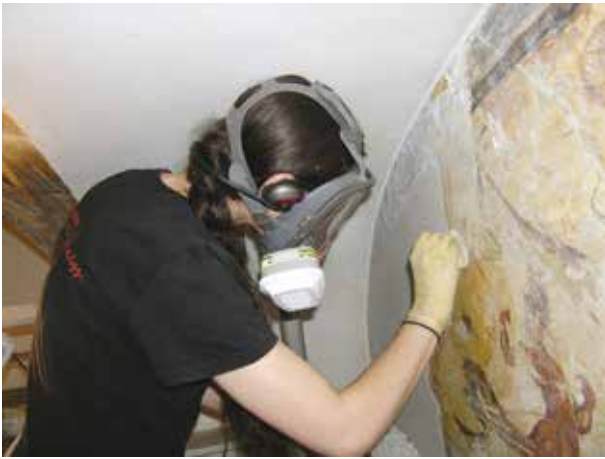
8. The process of uncovering the lunette in the north side of the foyer. Various superimposed and overlying layers were removed with a chemical solvent, photo by Tjaša Pristov, 2008

The restoration process of uncovered paintings was quite demanding. Removing the paint with chemicals and using acetone in nitro diluent was extremely difficult. More than half a year restorers worked in extremely difficult and health-endangering conditions, wearing protective gloves and masks all the time. After uncovering, it became clear that the entire area was heavily damaged.

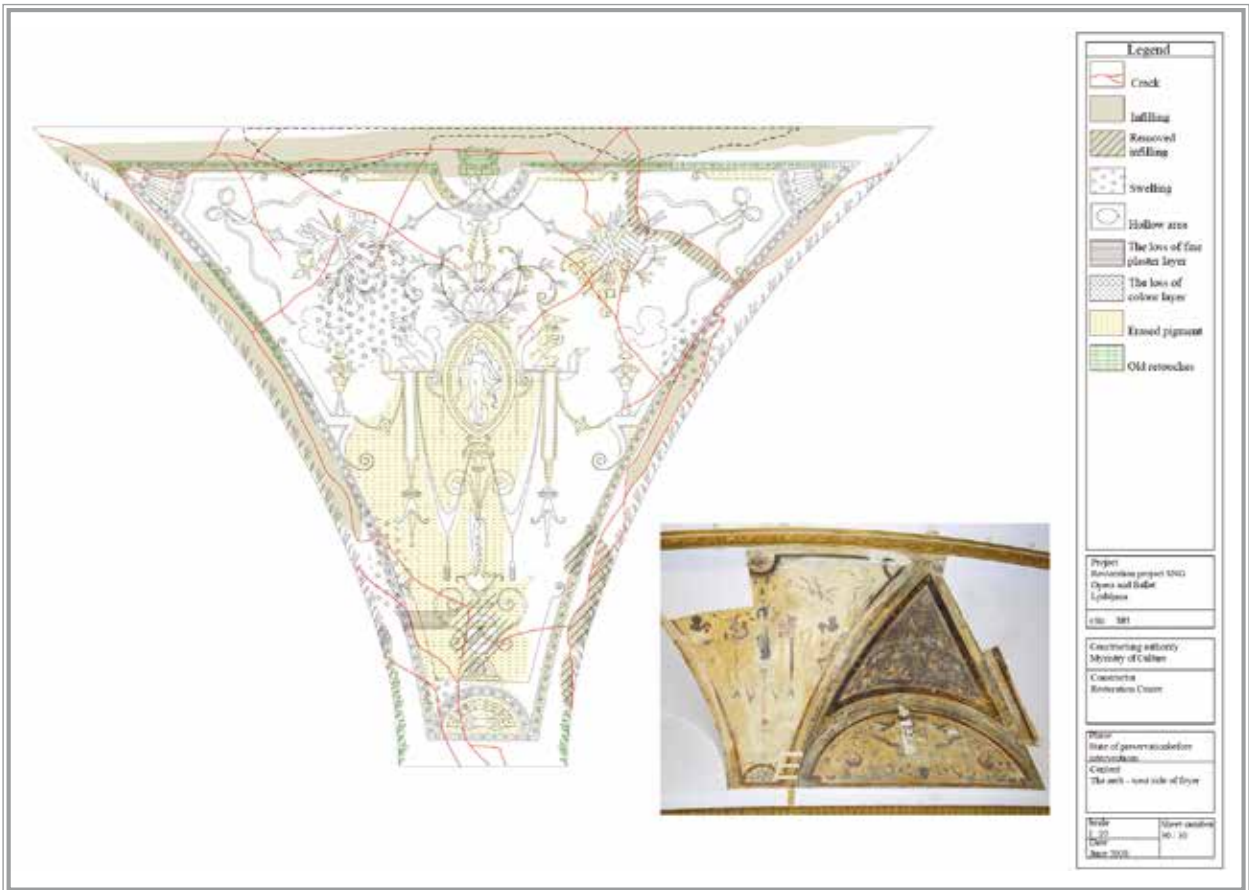
9. Graphical documentation of deterioration phenomena in the arch in the west side of the foyer

Therefore, in the first phase, the mapping of all deteriorated areas and the recording of deterioration phenomena such as numerous cracks, lacunas, abrasions (scratches), swelling of plaster and paint layers as well as inappropriate an intervention in the past, was necessary for compiling sufficient documentation on the preservation of paintings.

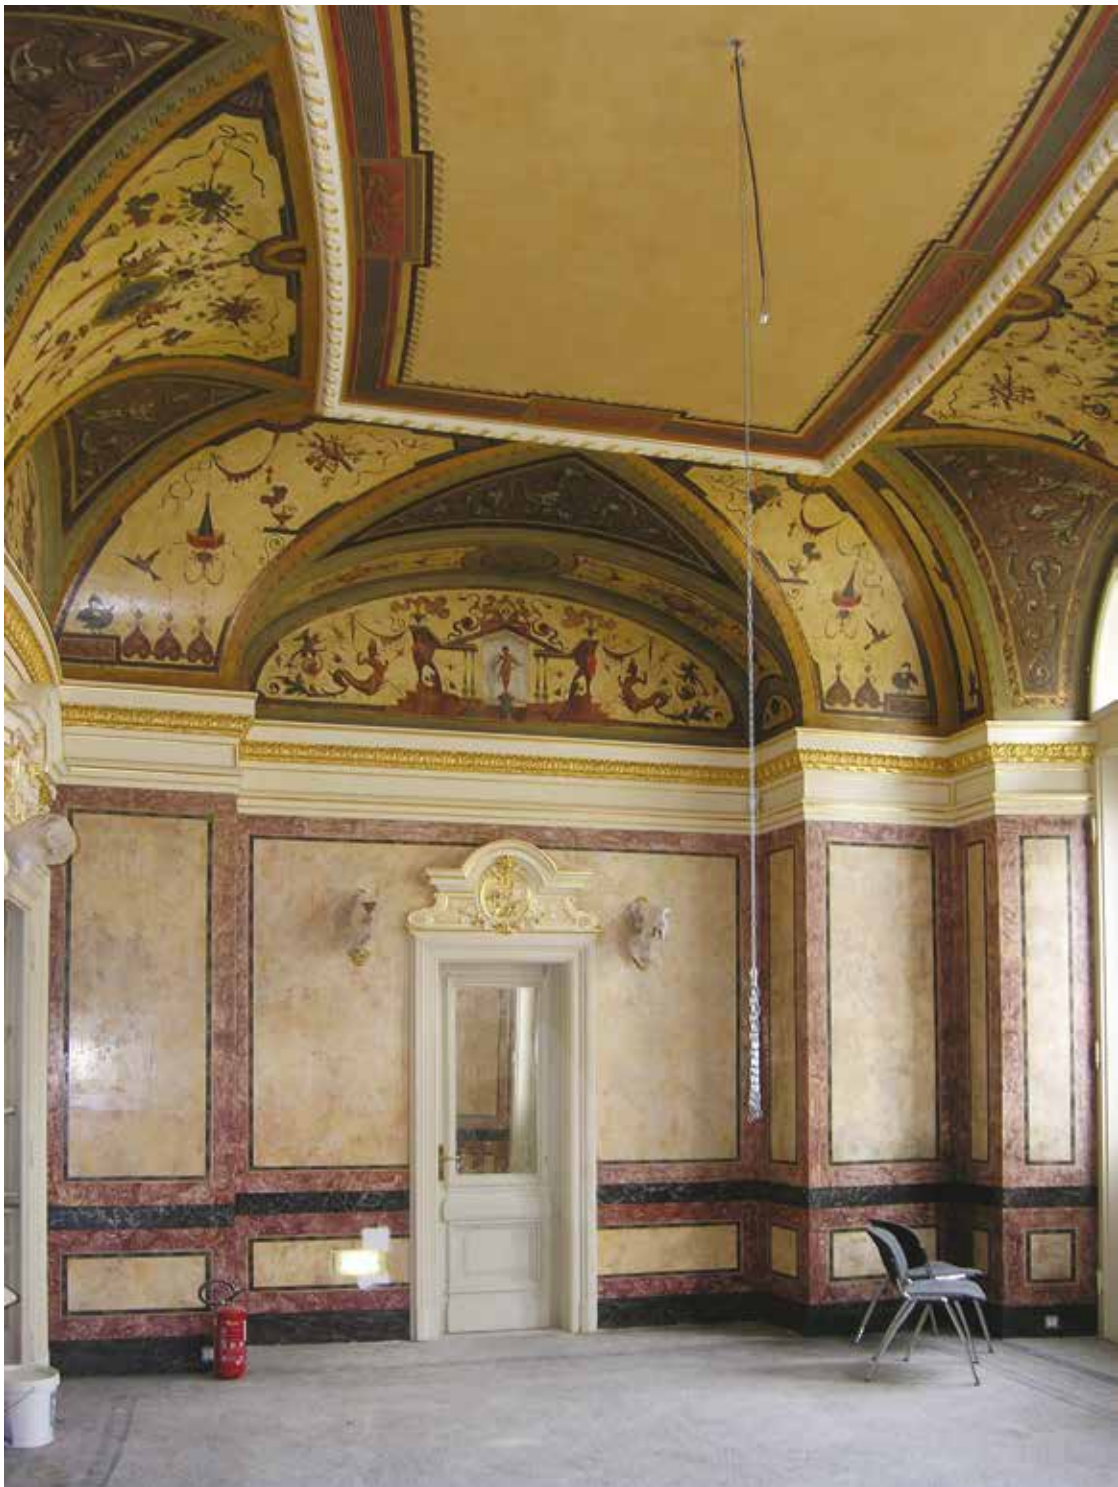
10. North side of the foyer after completing restoration interventions on the walls and the ceiling, photo by Tjaša Pristov, 2010

Conservation-restoration of the *stucco-lustro* marmorino walls represented a real challenge because of a complex technological process. Before starting the work, various experiments of making *stucco-lustro* were performed for the purpose of testing the quality of execution and the mimetic adequacy of the surface. The first treatment trials were made on a portable surface, and the next ones – in situ. Taking into account the good results of treatment trials, it was decided that the deteriorated wall marmorino could be entirely reconstructed in the original technique [ill. 10].

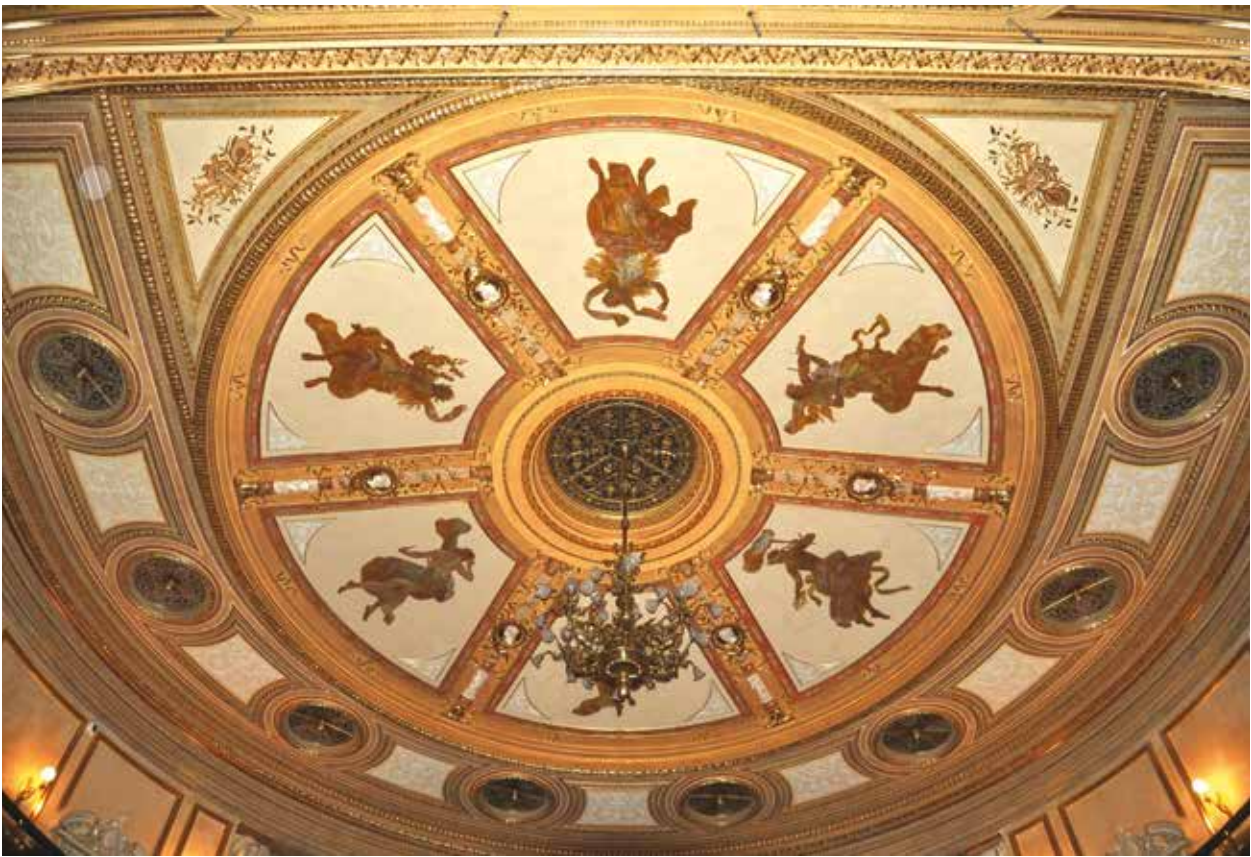
12. Painting on the ceiling of the auditorium after the finalization of restoration interventions, photo by Tjaša Pristov, 2011

On the basis of stratigraphic analysis, small parts of the original painting were fully uncovered on the lunettes of the proscenium above the stage. The same conservation-restoration procedures as in the lobby and the foyer were used for the plaster, insulation and the colour layer prepared in the same manner. A deteriorated paint layer (scratched and destroyed before applying a superimposed layer of paint) was retouched and partially mimetically reintegrated [ill. 12].

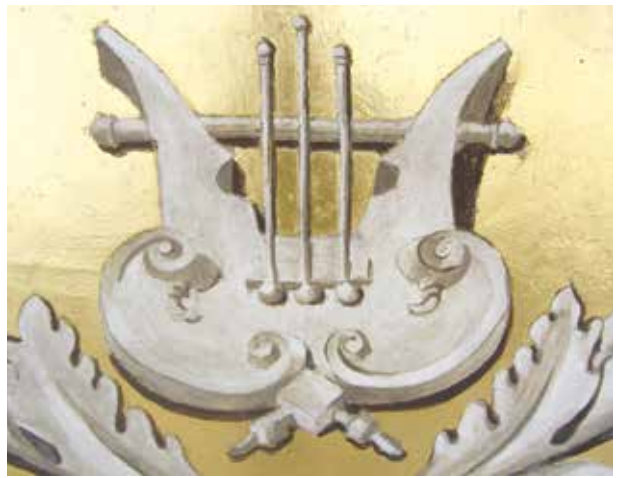
Despite the fact that the paintings on the frieze of the northern, southern and eastern façades were already restored in 1961, they deteriorated again to such an

extent that restoration was needed. The main cause for deterioration was the negative impact of atmospheric influence, strong sun exposure, and possibly inadequate materials used in the previous restoration. Since there had not been enough data available for an authentic reconstruction of the original *sgraffito* technique, the heavily deteriorated decorative paintings on the frieze and the turrets were reintegrated using the *secco* painting technique [ill. 13].

13. Detail of the paintings on the central frieze of the façade after restoration interventions, photo by Tjaša Pristov, 2009

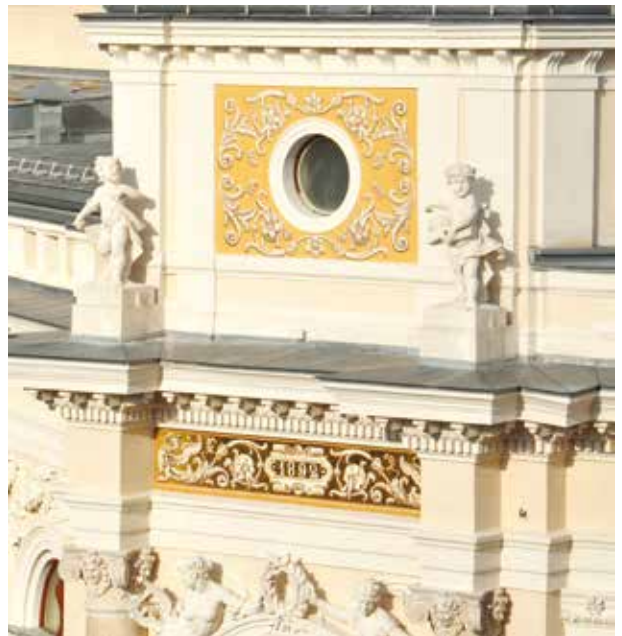
The golden background of the painted decoration on the frieze was generally in a poor condition. The surface was heavily washed out and worn out, without any gloss. Since the local treatment of the damaged gilded surface alone would have been too disturbing for the overall look, it was decided that the

14. Paintings on the tower and the frieze of the south-eastern part of the building after the completion of restoration interventions, photo by Tjaša Pristov, 2010

golden background needed to be fully reconstructed. Retouching of the damaged parts of the painting was carried out locally with pigments and acrylic emulsion Sokrat 2802 NA. Where the original colour layer had faded significantly, tonal adjustment was used to achieve the unification of the painted surface. Just like in the original, painted shadows of the motif were added over the golden background. Almost completely destroyed and almost unrecognizable decorative paintings on the turrets were reconstructed in the *secco* painting technique with Keim mineral exterior paint in order to minimize the deterioration caused by negative atmospheric influence [ill. 14].
