Applied Artists as Creators of Ceramic Monumental Art in Soviet Estonia: The Past and the Future

Hilkka Hiip, Anu Soojärv and Varje Õunapuu

Estonian Academy of Arts

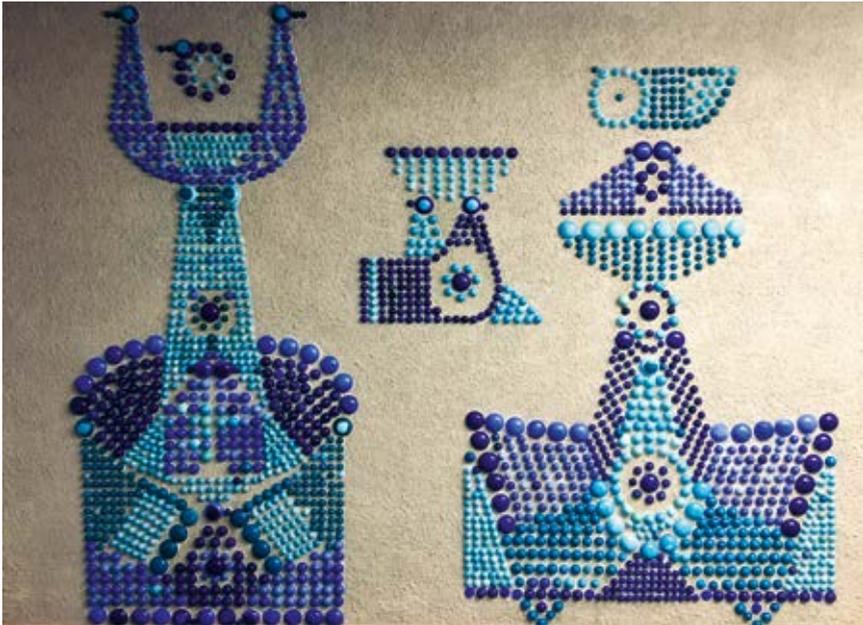
2.
The mural in 2019 after the restoration works, photo
Siim Hiis

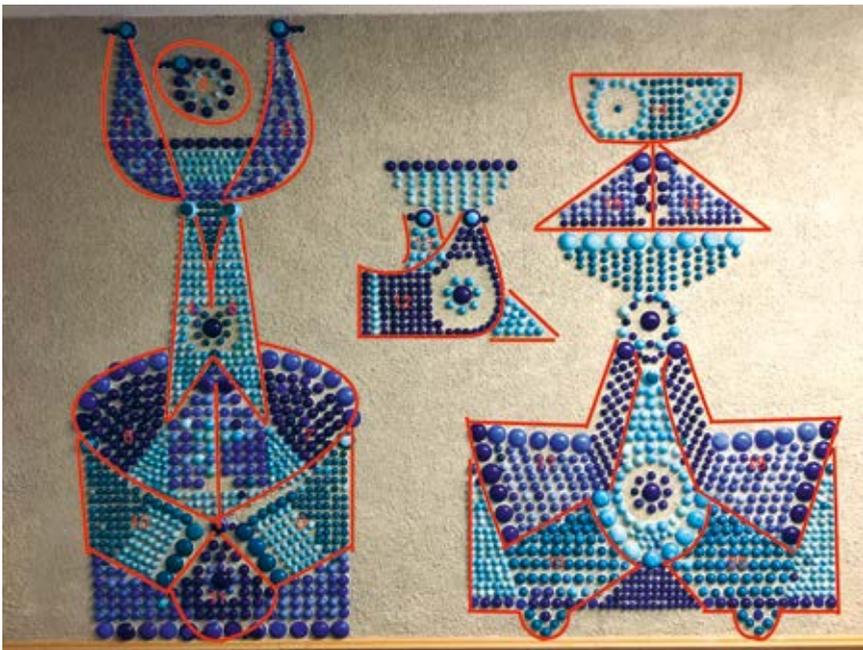
ceramic semi-spheres forming bird and female figures. The assignment for Rank-Soans, who was a student at the time, was given by her supervisor, the ceramist and pedagogue Helene Kuma, who was in direct communication with the architect of the administrative building of the poultry center. In one of Rank-Soans's interviews recorded and transcribed in 2019 by the students of the Estonian Academy of Arts,¹⁰ the artist said that the task was to create a figurative mural, and her inspiration came directly from the function of the center. She wanted to create something different from what she had seen before in figurative art, and the result came out rather abstract [figs. 2, 3]. Rank-Soans explained in the interview that the starting points for the composition were the spheric egg-shaped modules which she used to create the figures of the bird keepers and the birds depicted in the

3.
Schematic drawing showing the abstract bird and
female figures which the mural is depicting, photo
Siim Hiis, 2019

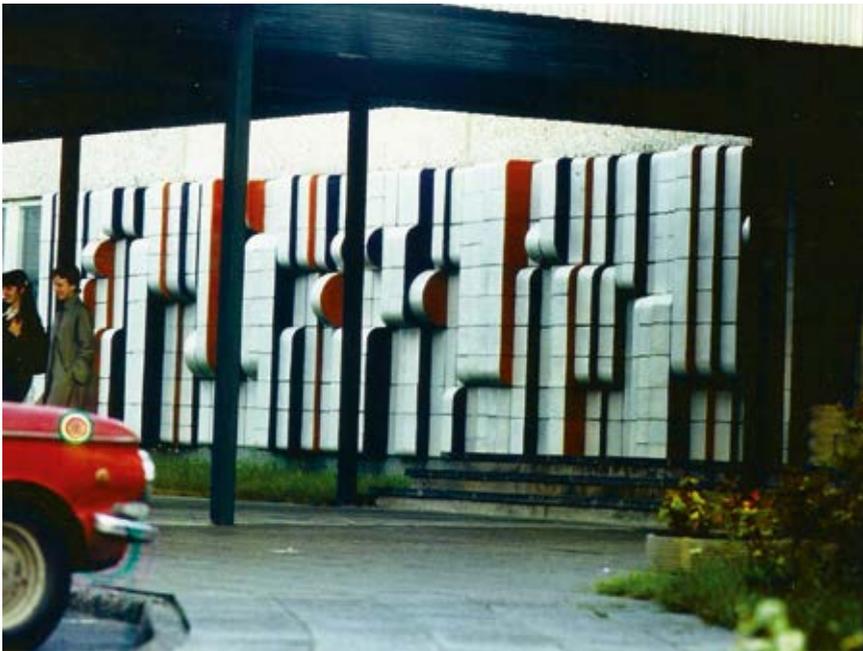
In 1978 the artist finished his work and the mural was installed on the facade. It consisted of 427 elements and its size was approximately 45 square meters. Yet a complication occurred. The idea for the Party school

5.
Mural after the installation in 1979, courtesy of Leo
Rohlin

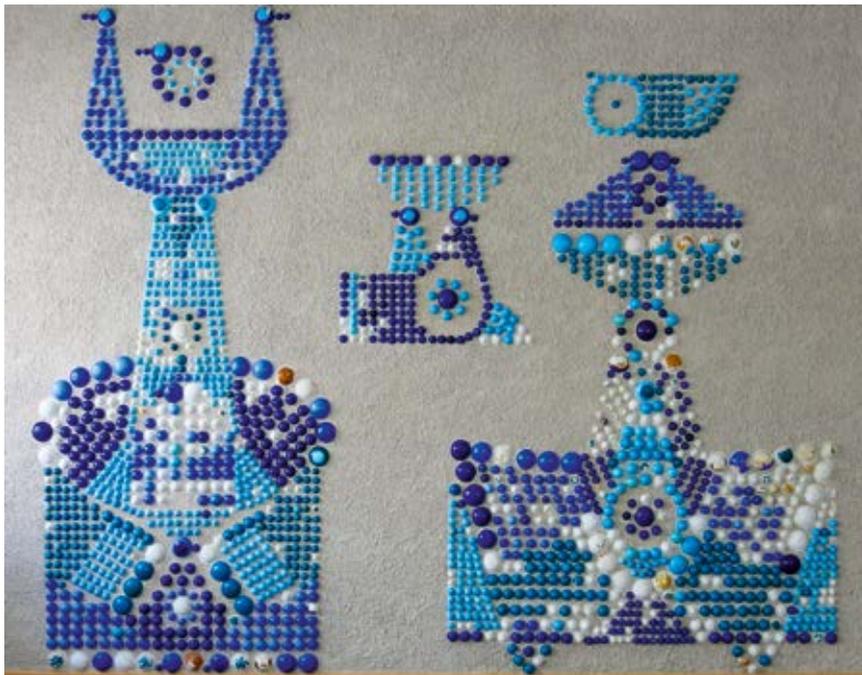
6.

Mural before conservation. All together almost 10% of the ceramic elements had to be replaced or repaired – 250 of 3500, photo Siim Hiis, 2019

Our examination of this mural started in 2019 when a student workshop with the aim of carrying out conservation work on the art piece was held.²¹ The main problem was that many of the glazed modules which the mural consisted of had been lost or come loose [fig. 6]. During our background research, we contacted the artist herself to ask her opinion about the restoration of the mural and to discuss the creation process and the materials she had used 52 years before.

with the artist revealed that she still had some leftover original modules stored away which we could use to replace the lost ones, and that is what we decided to do. As many as possible of the “original” modules were used, and those we could not replace were modelled by using gypsum, which was later painted to match the original color [figs. 7, 8].

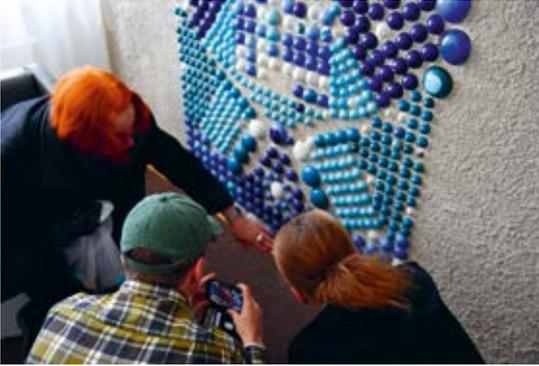
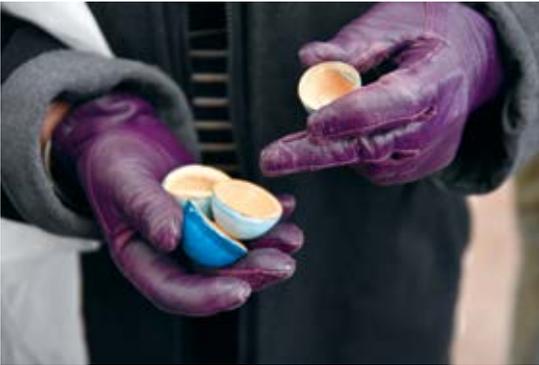
7.
Discussion with the artist (on the left), photo Grete Nilp, 2019

8.
Anu Rank-Soans holding the modules,
photo Grete Nilp, 2019

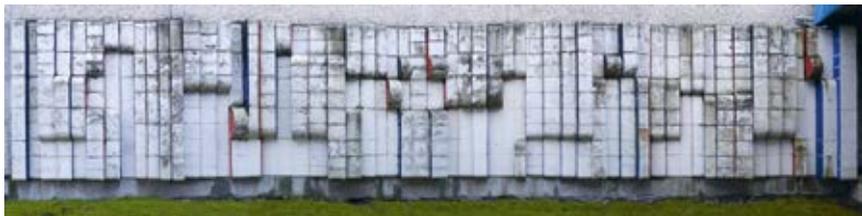
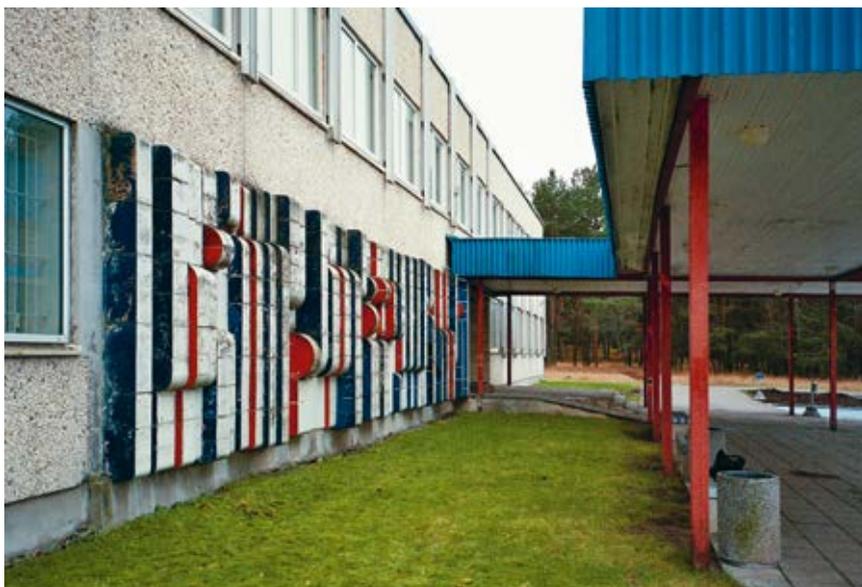
9.
View of the mural from the front, 2019, photo Taavi
Tiidor

10.
View of the mural from the left side, 2019, photo Anu
Soojärvi

Surprisingly, the fire clay truly lived up to its reputation. Although the mural had stood for 40 years totally exposed to weather, it basically had held up well. The glaze was partially gone, but it hadn't lost much in appearance. Very few of the elements were broken.²²

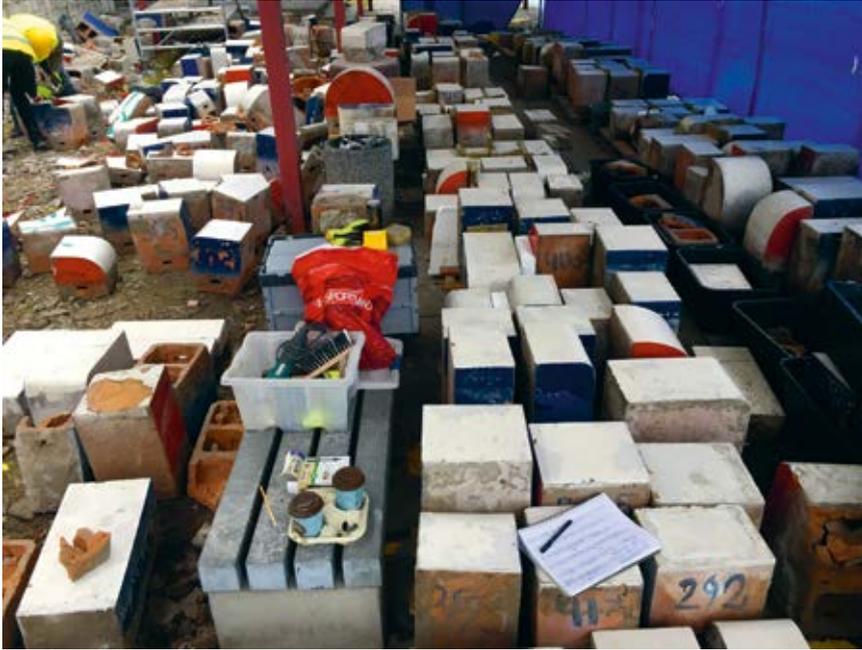
11.

Mural during dismantling, 2019, photo Hilikka Hiiop

The first step was to de-mount the mural, with each element weighing up to 40 kilos. All of the mural's units were attached to the metal skeleton with cement and dowels. After the elements were removed, they were numbered and cleaned. Hundreds of de-mounted elements were placed in an empty warehouse [fig. 11].
