SAVING THE SOVIET HERITAGE – DEMOUNTING MURALS FROM BUILDINGS DESTINED FOR DEMOLITION¹

Hilkka Hiiop, Helen Volber, Johanna Lamp

ESTONIAN ACADEMY OF ARTS / ART MUSEUM OF ESTONIA

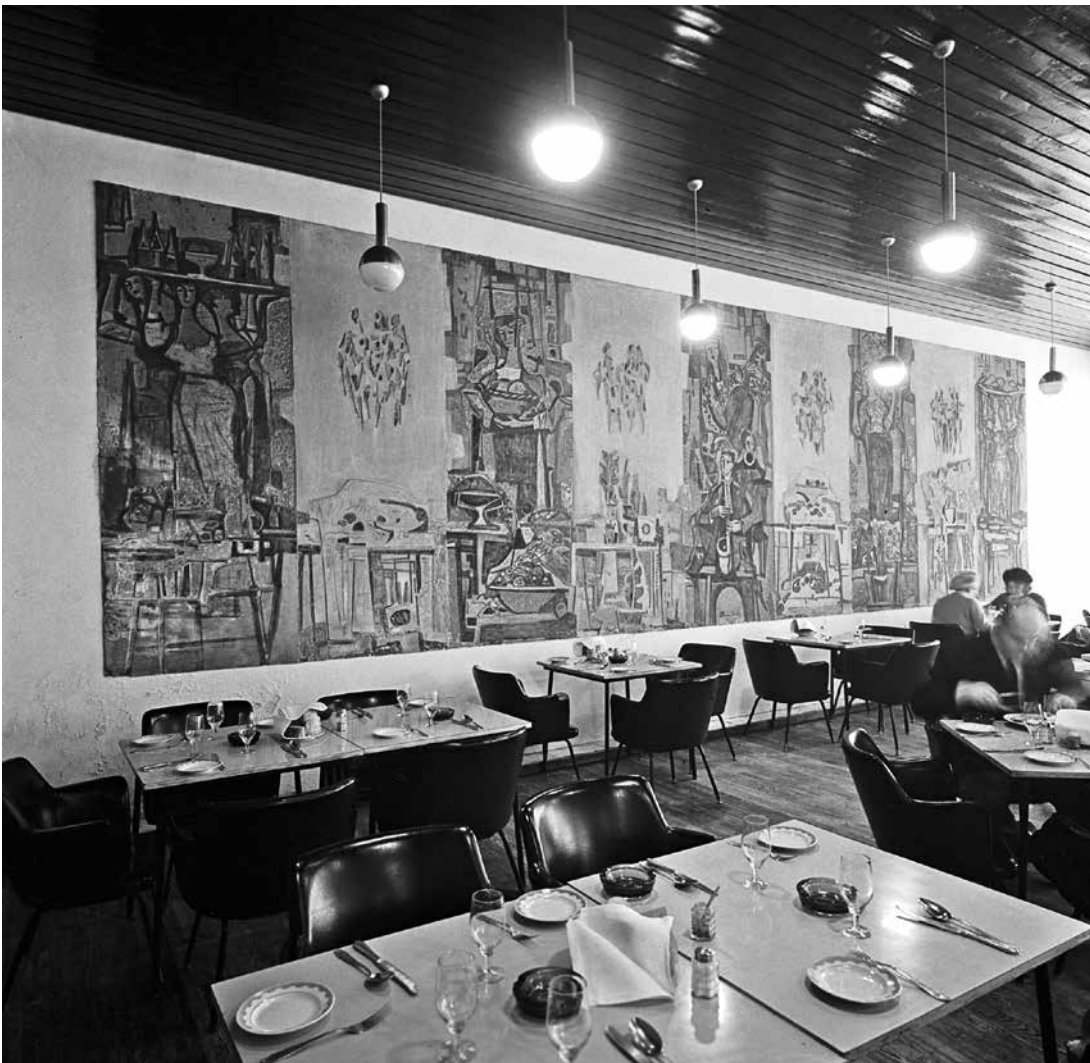
1. Mural painting by Elmar Kits in Tartu's old department store, 1965

was undeniably one of the most distinguished artists of Soviet Estonia. His sgraffito-style mural painting located in Tartu's old department store was completed in 1965 and originally adorned the wall of the Tarvas restaurant [ill. 1].

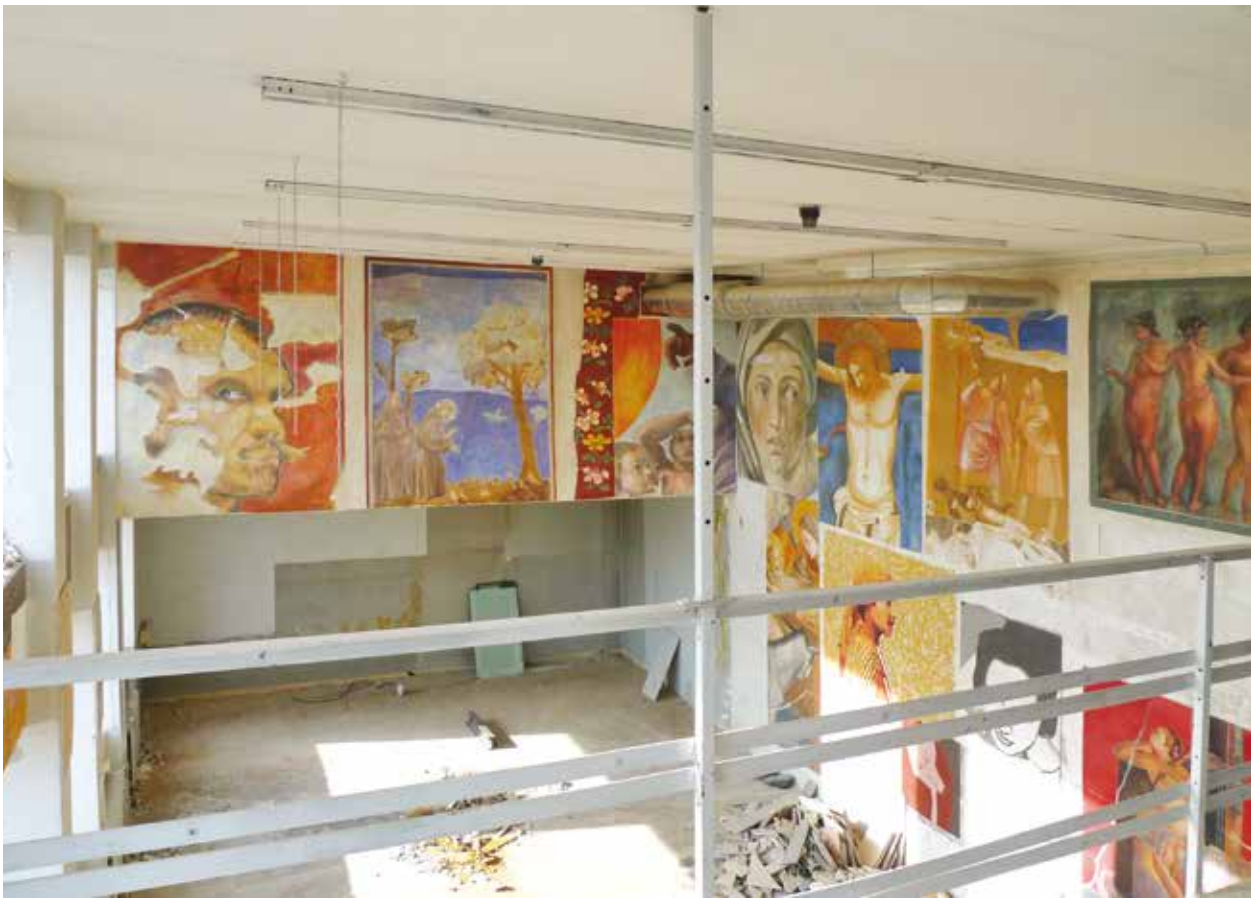
2. Mural paintings in the demolished building of the Estonian Academy of Arts, photo by Hilikka Hiiop, 2010

A precedent was set in the course of the demolition of the Estonian Academy of Arts building in 2010, when the school's cultural heritage and conservation department successfully demounted the more valuable mural paintings located in the building. From the beginning of the history of the building in the 1960s, the walls of the school had been used as a training space for mural paintings. Many of those paintings were made by artists who now occupy a dignified place in the history of Estonian art, and some of these works have been the symbols of the Academy of Arts for several generations [ills. 2 and 3].

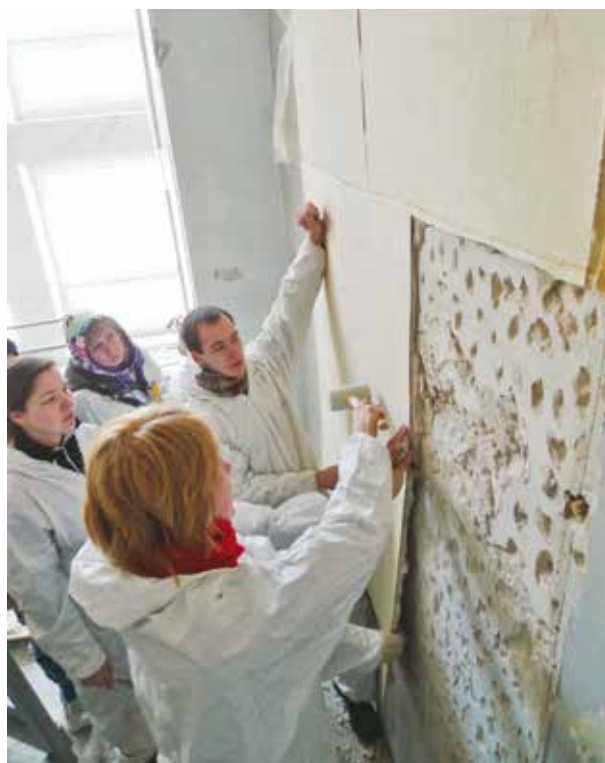
3. Conservation students of the Estonian Academy of Arts and the Tartu Art College demounting a mural painting, photo by Hillka Hiiop, 2010

of this technically engaging method of preservation. Two layers of fabric were affixed to the paintings with strong adhesive made from animal products. After the adhesive had dried, the frescoes were removed in strips from the walls together with the support plaster and placed in a repository.

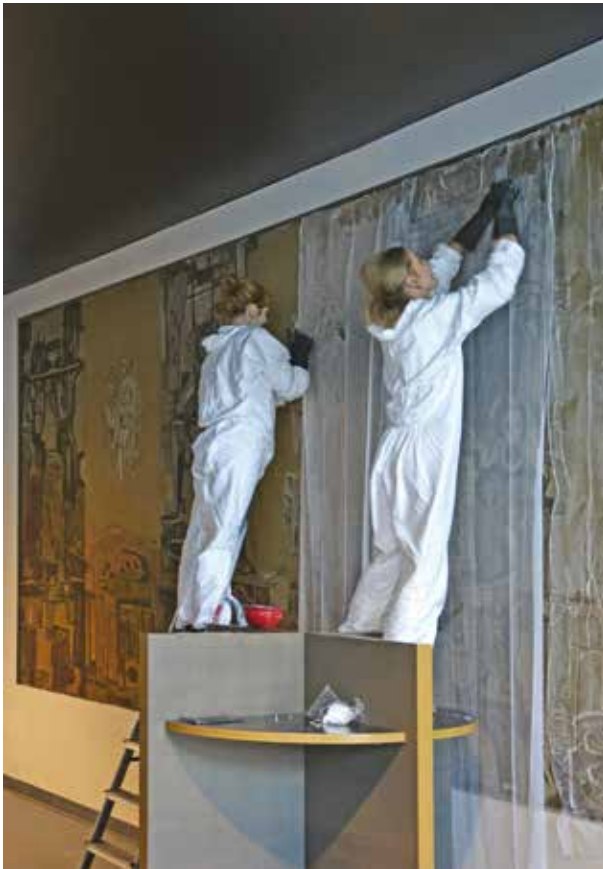
4. Application of prophylactic adhesive fabric, photo by Ülke Jukk, 2013

The mechanical removal of panels of the painting from the wall could have been very dangerous for the painting's surface. Thus, the painting was pre-emptively covered by layers of protective fabric to prevent the cracking and crumbling of the plaster and damage to the pigment layer in the process of demounting.

The advantage of natural adhesive is the harmlessness of the process (both prior to demounting and after remounting) to the people implementing it: large amounts of synthetic materials often create major health risks to those carrying out the work [ills. 4, 5 and 6].

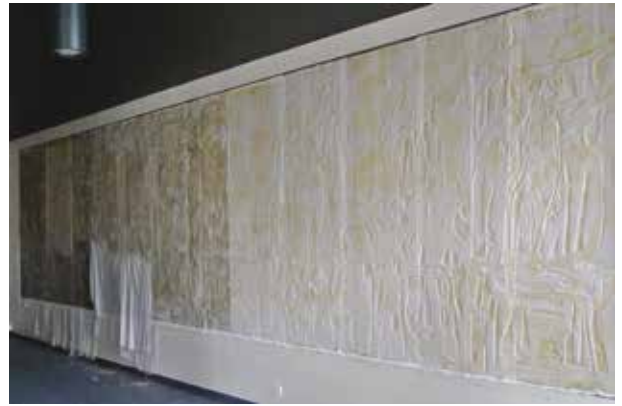
5. Mural partially covered by a second layer of fabric, photo by Hilkkka Hiiop, 2013

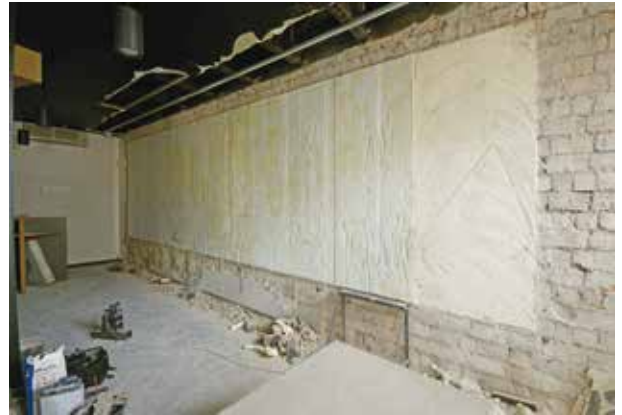
6. Mural covered by layers of prophylactic fabric prior to demounting, photo by Peeter Säre, 2013

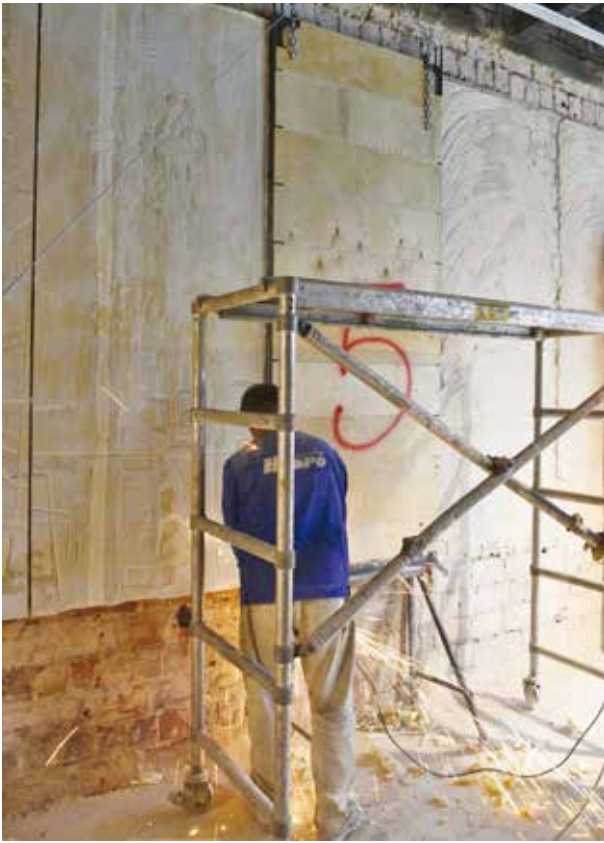
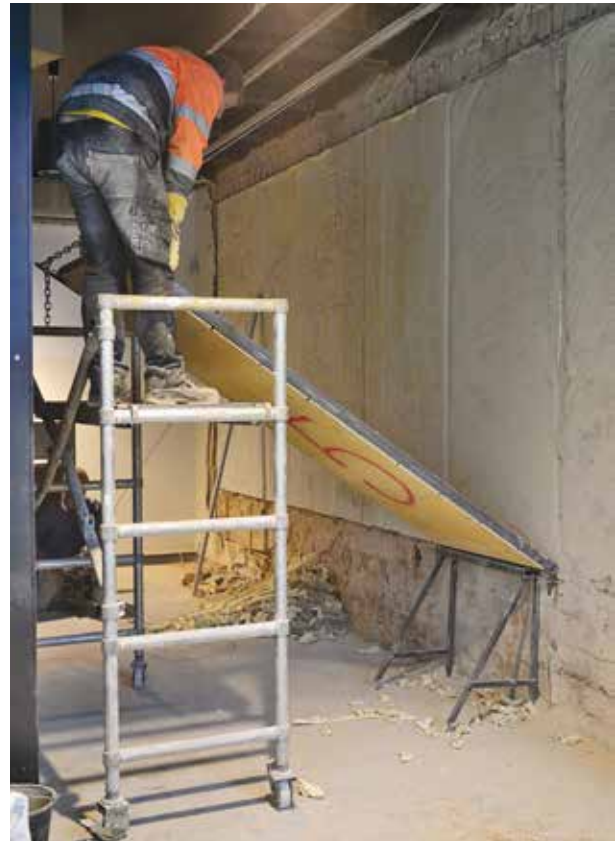
7 a, b The demounting process was successfully carried out by Haspo OÜ, photo by Ülle Jukk, 2013
Išardymą sėkmingai įgyvendino „Haspo OÜ“

In order to demount the mural painting, the edge strips, plaster panels, wall plaster and suspended ceiling panels were first removed to a sufficient extent to afford unrestricted access to the painting and to prepare the places where the hooks for hanging the work were to be affixed. The scenes of the painting were separated from one another using a circular cutter and the demounting began one by one, moving from right to left. A separate protective frame made of iron rods was constructed for each section. After fixing the frame, the panel with its protective layers of fabric was covered with an additional plastic film. A protective surface made of strong plywood was attached to the

front side of the painting and the frame was hung on a hook that had been affixed to the ceiling. The gaps that resulted in the deep grooves of the relief between the plywood and the plastic film were stiffened with stiffening foam in order to prevent cracking in the unsupported parts of the painting. Having dried, the plaster was sawed through, using a cable-cutting system, as close as possible to the brick wall. Then the panels were lowered using hanging cables into a horizontal position and their back sides were covered with reinforcing netting and a mixture of adhesive and reinforcement; having dried, it was covered with an additional layer of plywood to complete its affixing [ills. 7a and 7b].⁷

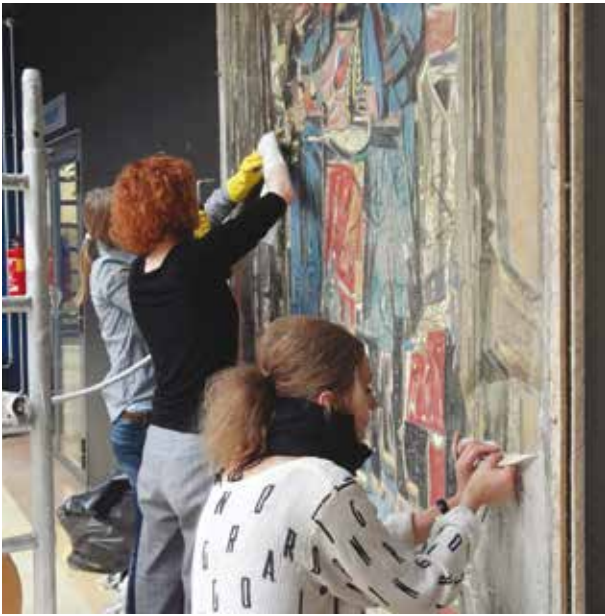
8. Conservators working on removing the protective fabrics from the already remounted mural in Viljandi, photo by Mati Valli, 2015

Now came the ‘moment of truth’: removing the protective fabrics would reveal the actual level of success of the entire undertaking. It was decided to use hot steam instead of water to reactivate the rabbit-skin glue in order to avoid the excessive use and absorption of water. The conservators breathed a sigh of relief as the layers of fabric and gauze started to peel off the mural easily and revealed the painted surface almost intact. Only a small area in the lower right corner of the painting was somewhat damaged during the re-mounting and needed some consolidation and a little plaster repair [ills. 8 and 9].

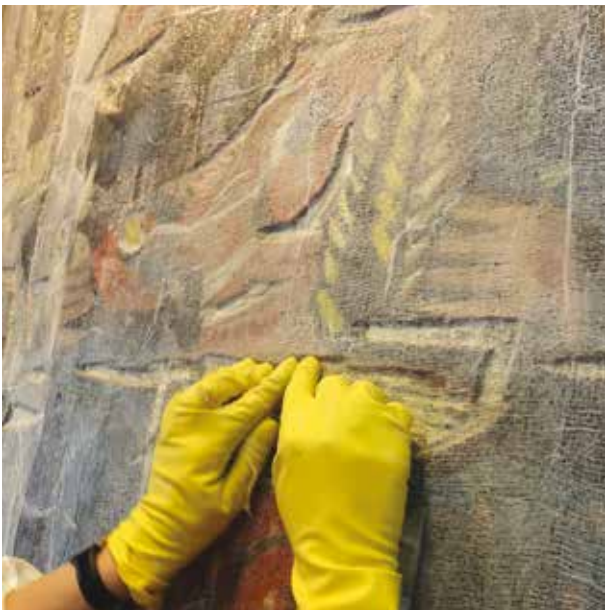
9. As with the mural in Tartu, conservators used gauze as the first protective layer, photo by Helen Volber, 2015

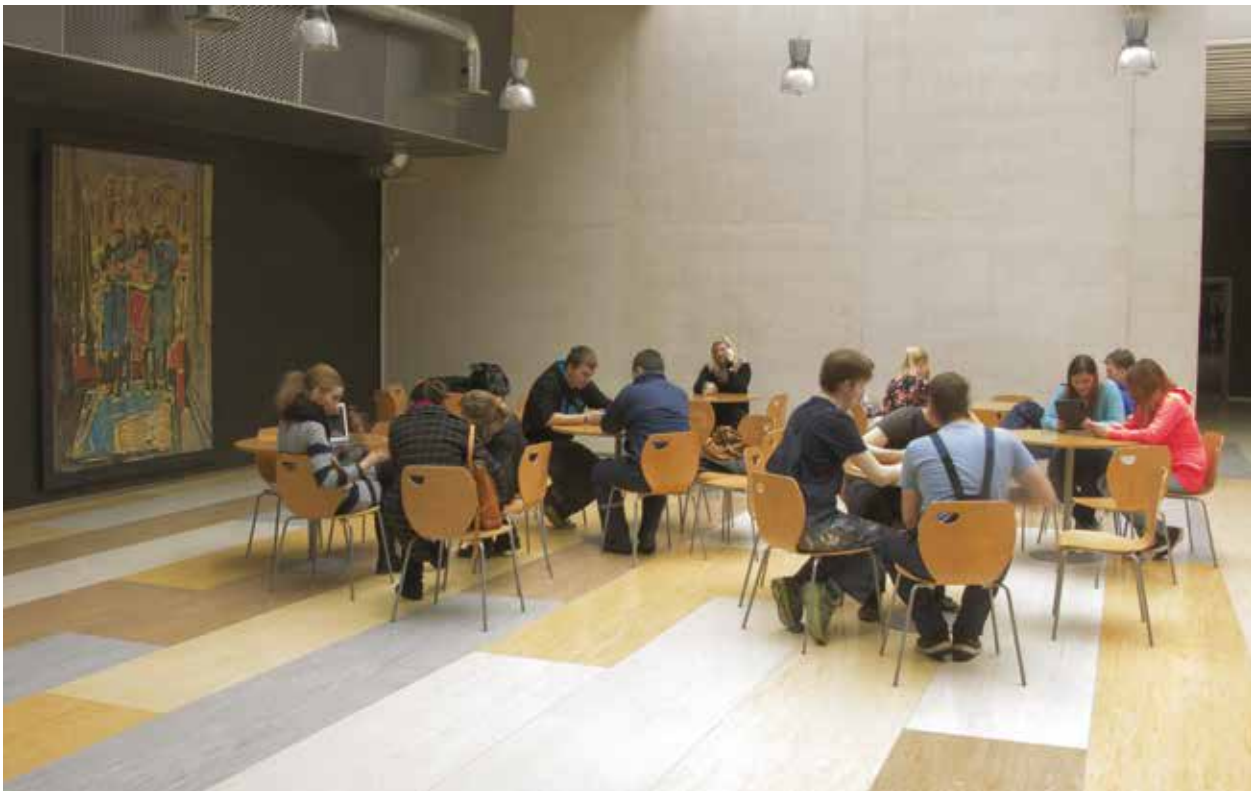
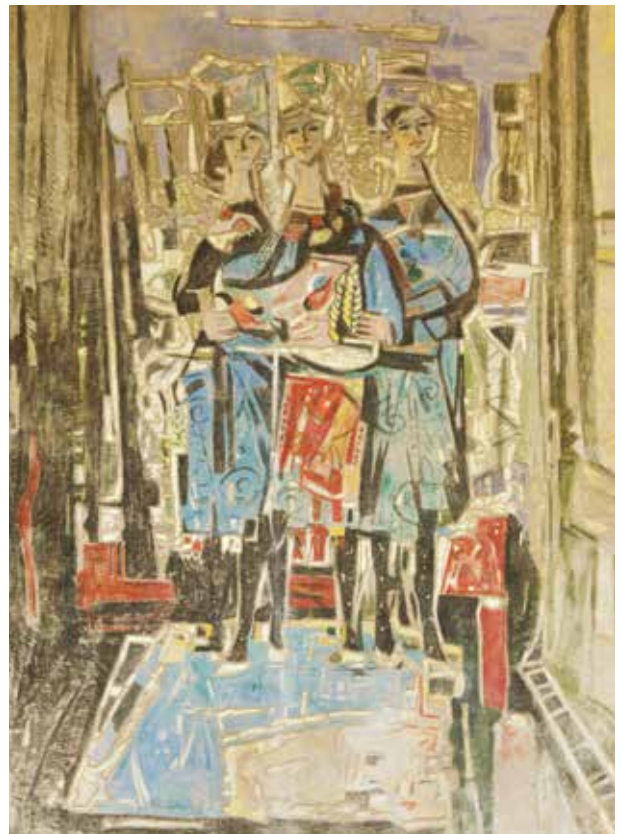
10, 11. Demounted and remounted painting by Elmar Kits in Viljandi, photo by Joel Leis, 2016

Slightly more time-consuming was the removal of glue residues from the painted surface. Again, the best tool proved to be the steamer, as well as a large number of absorbent towels [ills. 10 and 11].
