Conservation of Painted Church Interior Decorations of the Late Baroque Period in Latgale (2004–2018)

Rūta Kaminska

National Heritage Board of Latvia

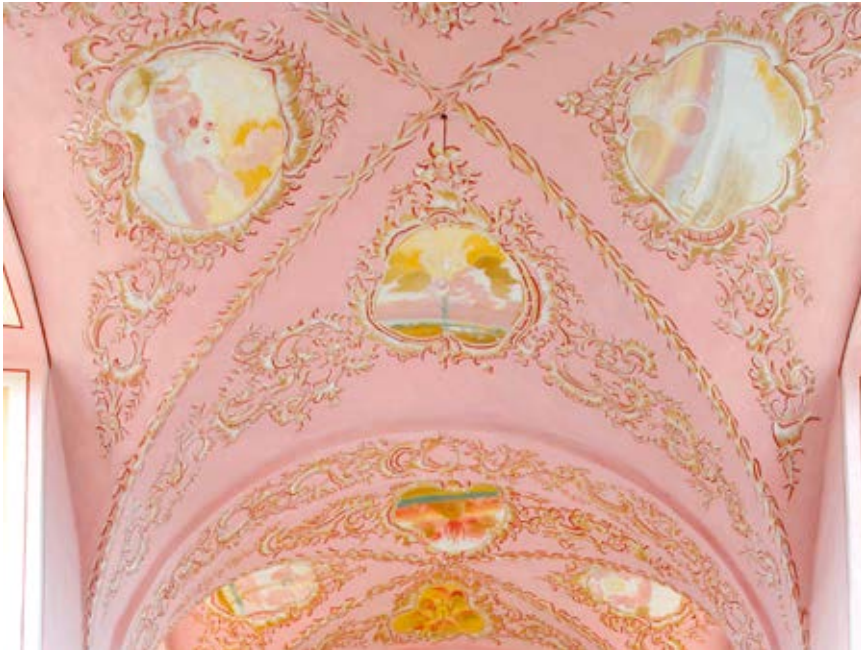
3.
Pasiene St Dominic's Catholic Church. Painted ceiling
decoration. Photo: Marika Vanaga, 2017

Now the church's painted interior includes the plafond and painted gallery railings. The painted ceiling consists of groin vaults in five bays; emblematic subjects are framed by rocaille cartouches on a pink background,

arranged in four groups according to the spheroid planes of the vaults. This composition is surrounded by rocaille bands, interpreted differently in the nave and the presbytery²⁵ which possibly points to a different date. Art historian Ojārs Spārītis presumably dates the painted plafond compositions to the 1770s–80s and relates them to engraving sample books of emblematics,²⁶ specifying a concrete source – engravings of Gottfried Eichler's painted compositions published by Johann Georg Hertel in Augsburg in 1758–1760.²⁷ However, research and the restorer's conclusions do not support this attribution,²⁸ leaving the preserved plafond to the Historicist epoch.

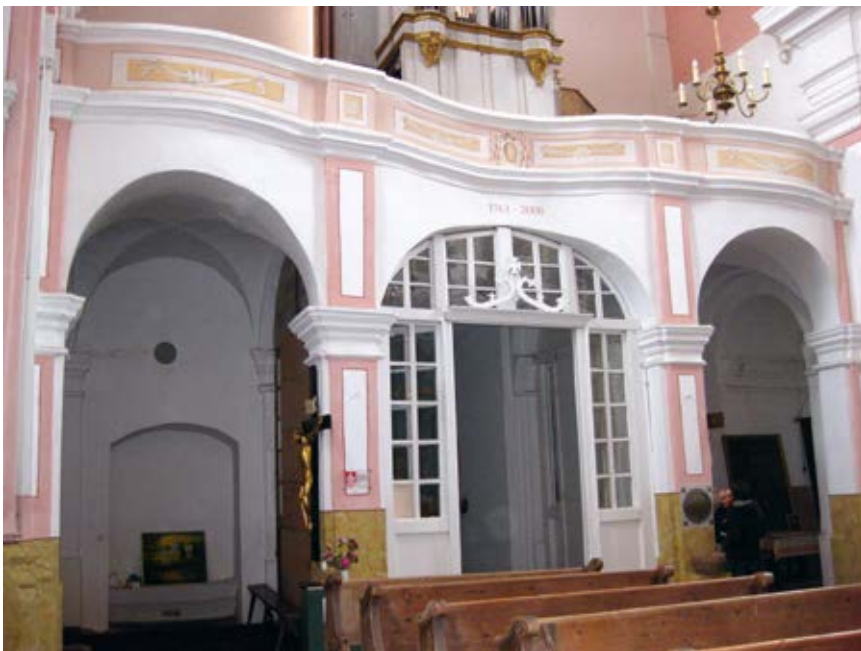
4.
Pasiene St Dominic's Catholic Church. Painted deco-
ration of the organ gallery. Photo: Rūta Kaminska, 2017

When the restorer Staņislavs Astičs²⁹ began working in Pasiene, he had to renovate the interior finish of the existing structure – tidy up the *stucco* décor of the altars and the pulpit as well as clean, reinforce and tone the plafond. As a result, the painted ceiling was preserved in its 1890s' form without an in-depth research and a possible discovery of an older painting layer if there were one. Therefore, repairs and conservation of the object were carried out, but the question of whether the original late-eighteenth century plafond exists beneath the layers of overpaintings still remains open. At the same time, the organ gallery railings have regained their initial polychrome Classicist-period décor.

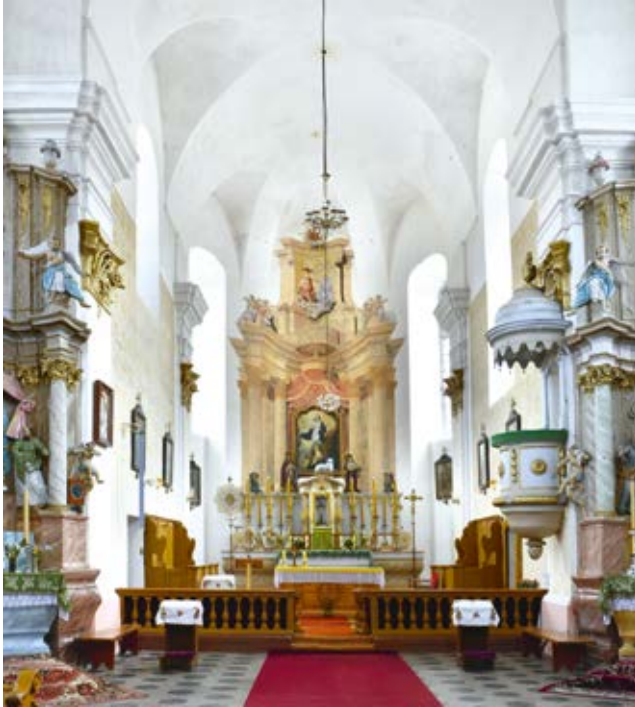
7.
Piedruja Catholic Church of the Assumption of the Virgin Mary. View towards the high altar before the conservation. Photo: Marika Vanaga, 2013

The painted retable of the main altar in Piedruja Church stands out against the whitewashed wall of the altar section. The retable composition includes a wall niche covered with the painting *The Assumption of the Virgin Mary into Heaven* (Pēteris Mironovičs,⁴⁶ 1935; oil on canvas). The illusive retable painting depicts an architectonic two-level construction flanked by Composite Order columns and pilasters. They support an expressively curved entablature and cornice with angel figures on its ends. In the centre, fringed draperies are painted around columns but over the niche there is a pink fabric canopy. The attic storey part is narrower, framed

Conservation of the Piedruja altar retable allowed concluding that the illusive painting in *buon fresco* technique on the brick wall with sand-lime plaster had been painted over many times with tempera and distemper paints, and partly whitewashed during later wall repairs.⁴⁹ Furthermore, the artist himself has changed the technique during the work, making corrections with tempera-distemper paints and covering up the damage done by spilled liquid paint. Also, the initial composition was somewhat altered in the upper part, switching the places of the Holy Trinity motif and the monogram of Mary. The conservation programme envisioned the cleaning of the authentic layer of painting from later strata, desalting and strengthening of the plastered ground as well as filling up the lost parts, toning of painting and the conservation of gilded details. Conservation of the mensa was carried out simultaneously. Removing subsequent layers, the second layer of painted décor was uncovered and exhibited. The altar composition was restored with a late Baroque polychrome solution. The church interior has regained the main colour accent – the polychrome painted altar but the side *stucco* altars still retain traces of primitive *stucco* repairs and remain under later overpaintings. As researches up to now have shown, the side altars were originally painted polychrome like in Pasiene Church; *stucco*

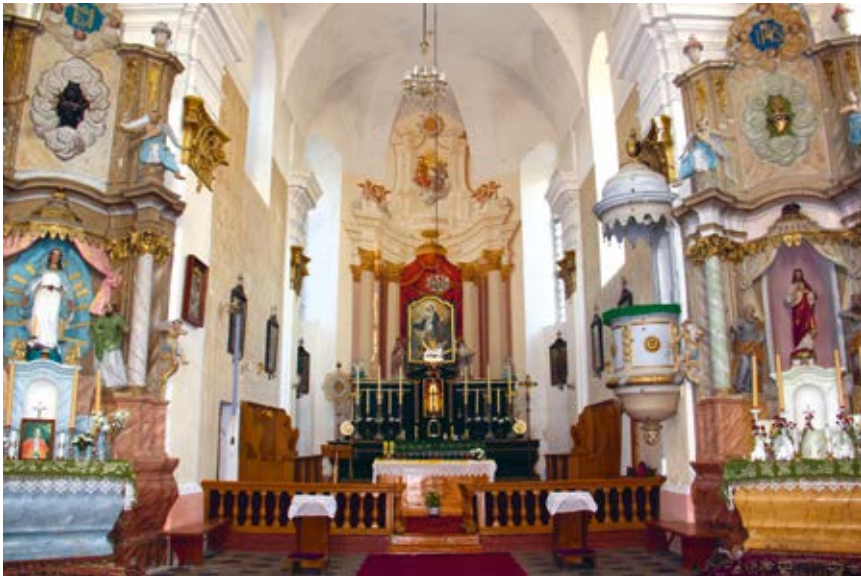
8.
Piedruja Catholic Church of the Assumption of the Virgin Mary. View towards the high altar after the conservation. Photo: Edīte Lukša, 2018

with pilasters entwined in volutes on the sides and topped with a cornice over which a beaming monogram of Mary appears. The Holy Trinity on the cloud background is painted in the centre of the attic storey. There is a wide, arched mensa with a tabernacle and a high tabernacle wall rounded off with painted, silhouette-carved figures. Italian painter Filippo Castaldi (1734–1814)⁴⁷ was hypothetically mentioned as the author of the painted retable but no documentary evidence has been found. The master was employed by the Count Plater family in nearby Krāslava in the second half of the eighteenth century. According to construction history data, the interior finish of Piedruja Church was possibly accomplished between 1760 and 1774 when the painter still worked nearby. It is known that he left Latgale and went to Rome in 1774⁴⁸ but later his life was closely connected to Poland.

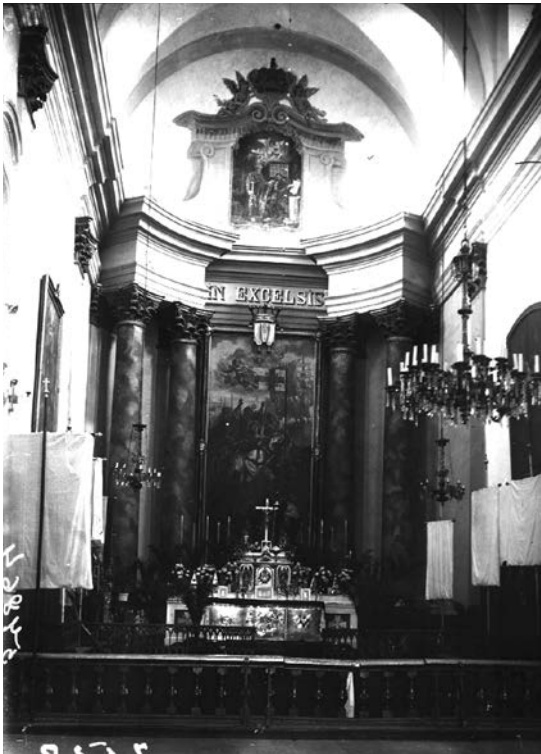
10.
Kraslava St Louis' Catholic Church.
The high altar. Photo: 1927, MDC

The main altar retable of Krāslava Church is architectonically constructed with a niche flanked by columns and pilasters in the centre, containing a *buon fresco* painting⁶⁸ on lime-sand plaster; it is a figural composition titled *St Louis Departs for the Crusade Blessed by the Archbishop*. The work is enclosed with a plastic frame with rocaillé décor. The altar's narrower attic storey is illusively painted, framed by side volutes and topped by a broken cornice with two angels holding a crown over it; Apostles Peter and Paul are seen in the centre of the attic storey within a painted frame. The *fresco* of the main niche has survived in a comparatively good state with little physical damage. Plaster had peeled off in the upper painting and there were some cracks, but the surface was covered with a layer of dirt and mould. The conservation programme envisaged cleaning the *fresco* surface, removing the dirt and upper layers, filling in the missing parts of the lime-sand plaster, camouflaging the cracks, reinforcing and toning the paint layer.⁶⁹ In the masonry construction of the retable, brick walls and columns are covered with *stucco* plastering and the surface is painted with tempera. Column shafts are painted to imitate marble, but the plastic parts are gilded.⁷⁰

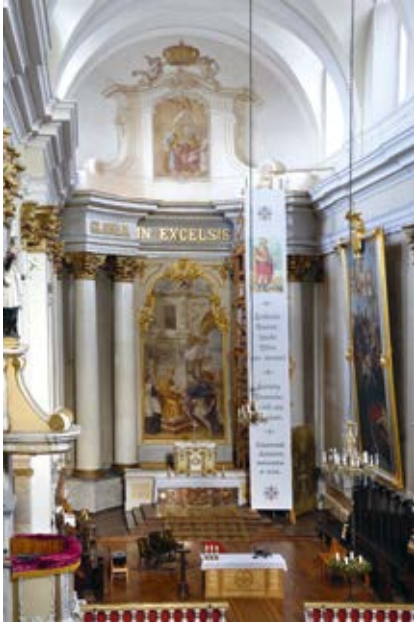
11.
Kraslava St Louis' Catholic Church. The high altar.
Photo: Marika Vanaga, 2014

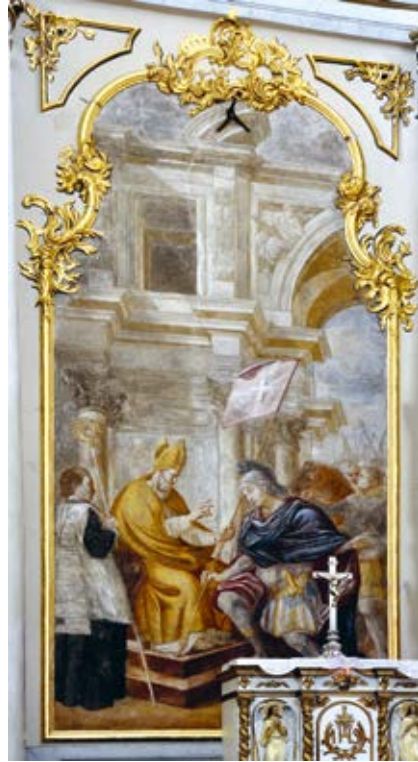
12.
Kraslava St Louis' Catholic Church. Filippo Castaldi.
Fresco painting of the high altar. Photo: Marika
Vanaga, 2014

When conservation of the main altarpiece began (2003), it was removed from the altar, thus uncovering the authentic *fresco* painting in the centre of the retable. As the research progressed, painted retable compositions of the side altars came to light,⁶⁵ previously partly covered with the late-nineteenth century retables and partly painted over. Probing has also revealed the painted décor of the sacristy that was previously unknown.⁶⁶ Now the main altar has been restored by the efforts of restorers Kristīne Širvinskā, Pāvels Rosovskis, Dmitry Lashchetko, Tomasz Dziurawiec and Agnieszka Chojkowska-Sawicka.⁶⁷ Altar conservation proceeded in several phases (2004–2006, central *fresco*; 2008–2011, attic storey; 2012–2015, decorative painting of the architectonic part). Latvian and Polish specialists collaborated on this project with financial support from both Latvia and Poland.

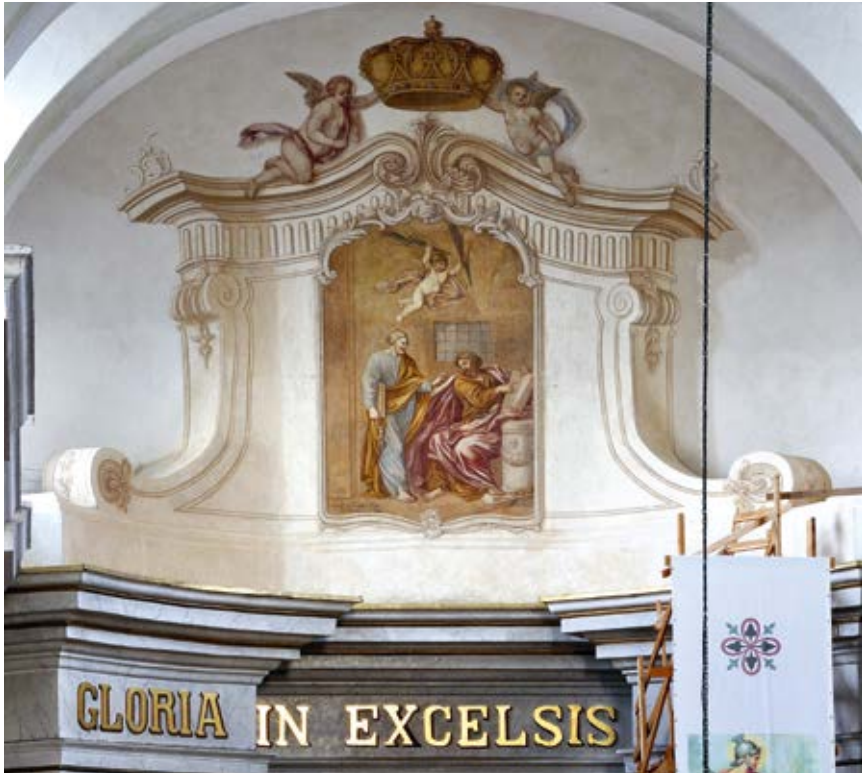
13.
Kraslava St Louis' Catholic Church. Filippo Castaldi.
Fresco painting of the high altar's attic storey. Photo:
Marika Vanaga, 2014

The attic storey part of the altar was painted, combining *buon fresco* and *fresco-secco*. It has been altered to a greater degree; the conclusion was painted out, the architectonic part – painted over with seven to eight layers of tempera and oil paints.⁷¹ A canvas with an oil painting *The Holy Family* (1940s; painted over by M. Vagulevs, 1953) was glued to the central part.⁷² During the conservation, the central *fresco* was cleaned and toned, removing later overpaintings; the original composition of the attic part was fully uncovered, removing upper paint layers and the painted canvas glued to the central part. The architectonic part of the retable was cleaned, the paint layer was reinforced, and the lost parts were filled and toned. The altar has regained its original composition, but the nineteenth century altarpiece is now exhibited on the presbytery wall. The church interior has taken on a new accent that distances it from the heavy nineteenth century stylistics.

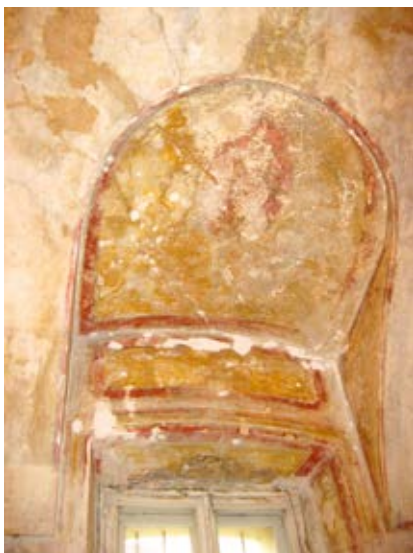
14.
Kraslava St Louis' Catholic Church. Painted decoration
of the sacristy ceiling. Photo: Rūta Kaminska,
2017

Conservation of the polychrome finish of the sacristy is now in progress (2016–2018, conservator Dmitry Lashchetko). Beneath layers of whitewash, the vaulted ceiling and walls of the sacristy have retained fragments of several polychrome strata on dry plaster, covered with seven to ten layers of oil paint.⁷³ The local specificity of the lime-sand plaster on the brick wall is the fallow tone of the plaster, given by the chemical composition of the local sand,⁷⁴ influencing the overall tonality. The oldest finish layer in the sacristy has partly retained the rocaille décor and the painted coats of arms in the centre of the ceiling vault (coats of arms of the Plater and Ogiński families). Around 1790, the subsequent polychrome layer was applied with a painted frame composition, organising the division of planes; several layers of paint followed later. Now the plaster has been reinforced, the polychrome décor from the 1790s and fragments of an older layer – exposed, and conservation works are continuing.
