# Challenges of Conservation and Restoration of a Medieval Wall Painting in the Church of Saint Leonard in Mala Ligojna and the Question of Its Authorship

Eva Marija Fras

Academy of Fine Arts Ljubljana

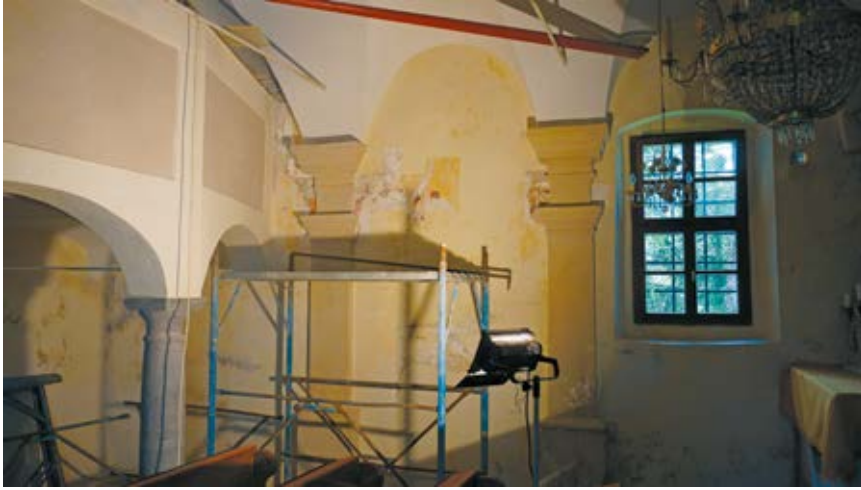
2.

During the Baroque period, some architectural changes to the interior were carried out [fig. 2] – the choir on the western side was added as well as two pilasters on the northern and two on the southern wall. The pilasters continue into the vaulted ceiling that replaced the old, supposedly wooden coffered ceiling. These Baroque-era transformations, including the window on the northern wall, caused significant damage and loss of substance to the original painting.

Northern wall with the choir; pilasters, vaulted ceiling, and window added in the Baroque period, photo by Eva Marija Fras, 2020

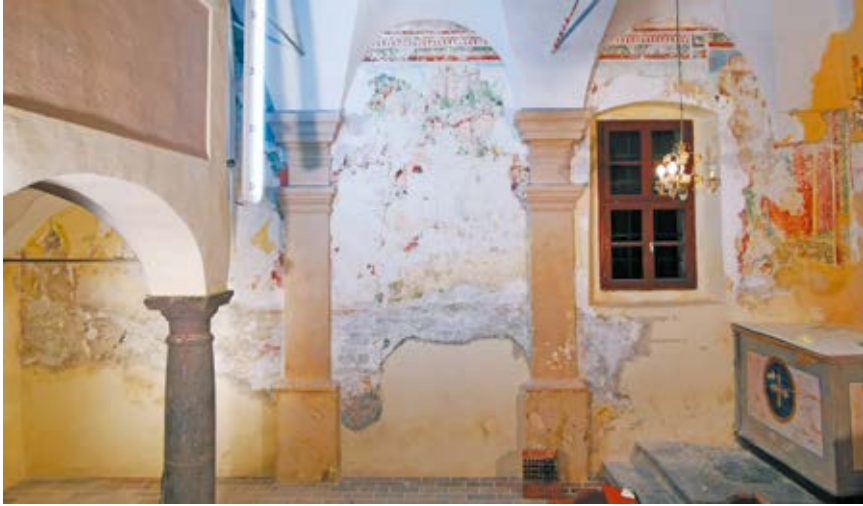
In the upper part of the wall, the paint layer is well preserved, while in the lower part, the adhesion of the paint layer and the plaster is strongly reduced due to active humidity [figs. 3, 4].

The general state of the painting is stable; it has some localized cracks and smaller craquelures. During the uncovering process, it was found that the paint layer on some parts of the wall is very well bonded with the secondary layer, and this will be problematic to remove without inflicting damage on the original.

3. Northern wall: visible gradual loss of the paint layer from the upper to the lower area, photo by Eva Marija Fras, 2020

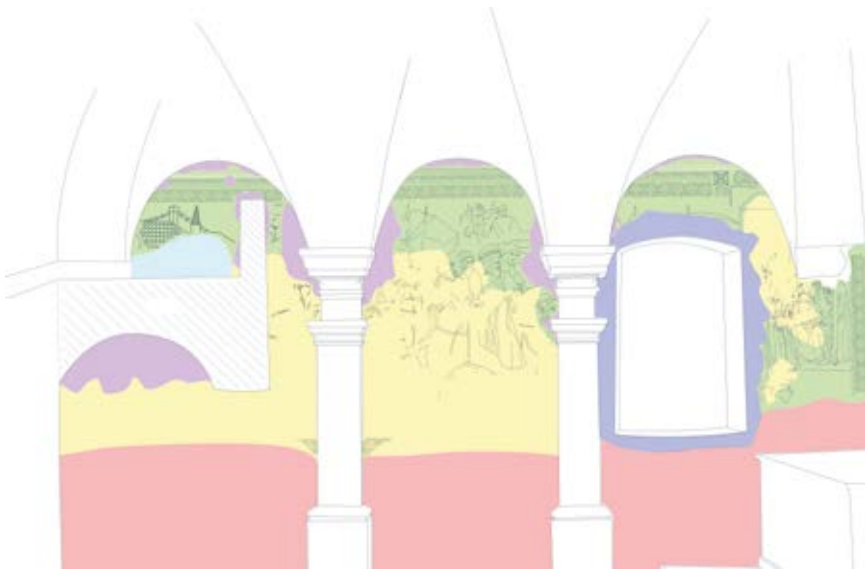
4. Degree of preservation of the paint layer on the northern wall in Mala Ligojna, made by Eva Marija Fras, 2020

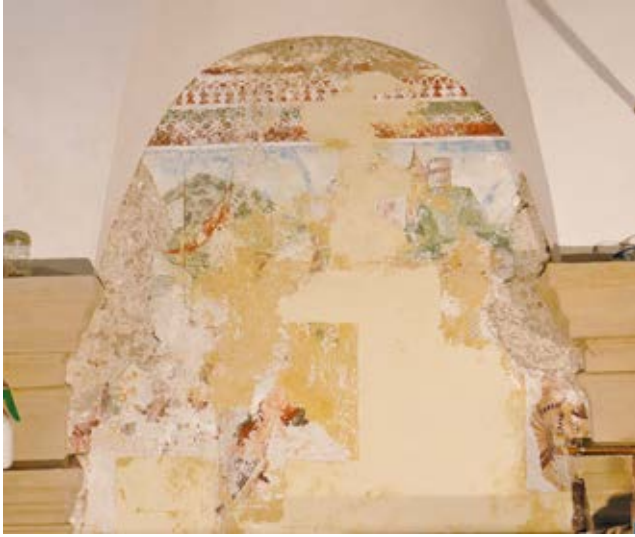
During the uncovering it was noticeable locally, on some larger areas, that the paint layer was already abraded and damaged before the application of the first historical whitewash. Also, in some areas the first whitewash fell off before the application of the second, ochre, whitewash. On these areas the ochre layer was bonded strongly with the paint layer [figs. 5, 6], and it presented the first problem we encountered in the process.

Due to the lack of cohesion and the strong adhesion it was not possible to remove the layer using a scalpel. The whitewash could be thinned but not completely removed. Various tests were carried out using various rubbers, sponges, and brushes, but none could break the very strong adhesion with the paint layer.

5.  
Central part of the  
northern wall: a  
large area of ochre  
whitewash, photo by  
Eva Marija Fras, 2020

After all the aforementioned tests for chemical removal and pre-consolidation were fruitless, a glass fiber brush was tried out.<sup>5</sup>

When using the brush, it was important to constantly follow the structure of the wall, since there are many bumps and peaks in the structure of the *intonaco*. The hardness of many thin glass fibers in combination with soft, even strokes resulted in a complete removal of the problematic ochre whitewash. In specific areas it was still a bit troubling, but to keep the paint layer intact, it was acceptable to leave minimal residue [figs. 7, 8].

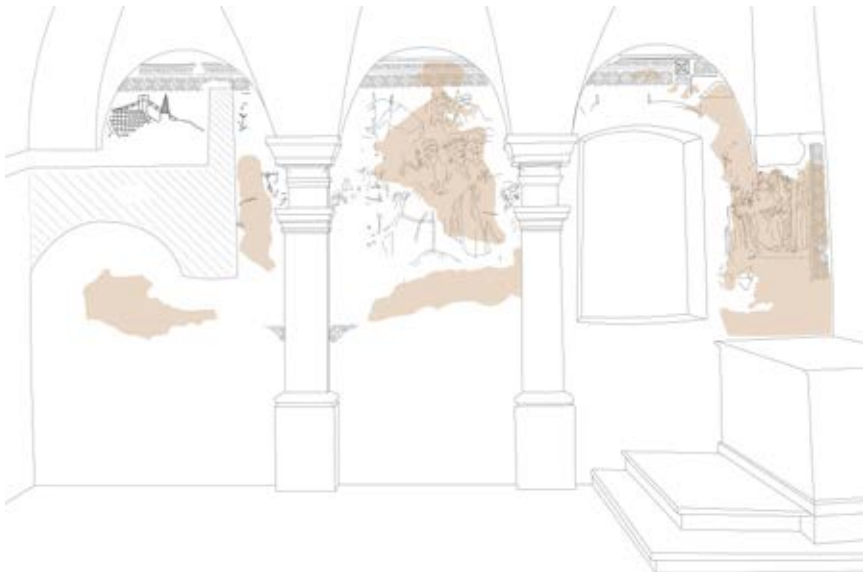
6.  
Areas with ochre whitewash on the northern wall, made by Eva Marija Fras, 2020

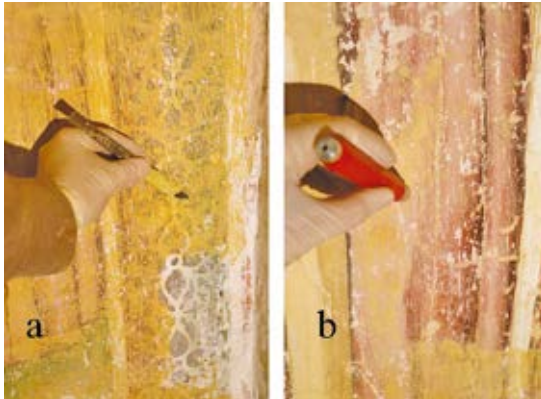
7.  
A. Thinning of the ochre layer with a scalpel; B. Removing of ochre residues with glass fiber brush, photos by Eva Marija Fras, 2020

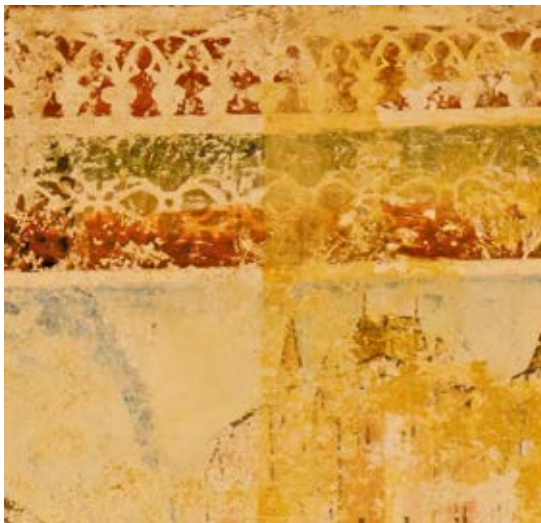
8.  
Difference between the uncovered painting on the left and the thinned ochre whitewash residue on the right, photo by Eva Marija Fras, 2020

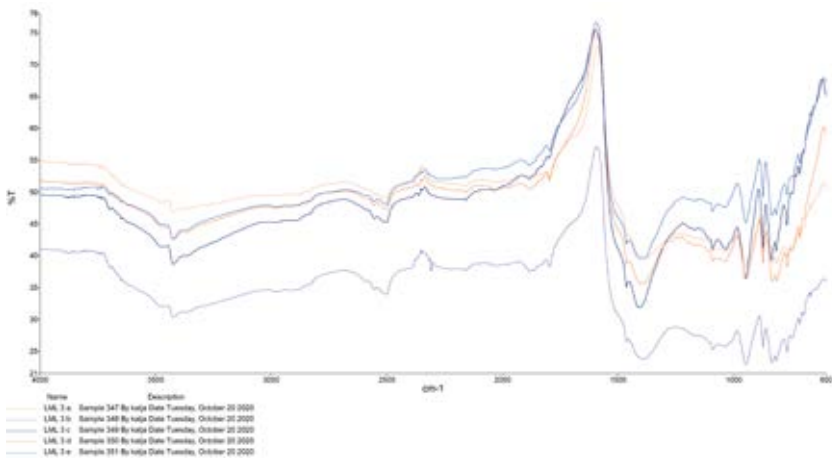
9.  
FTIR spectrum of the blue sample showing peaks for azurite, photo by Eva Marija Fras, 2020

To choose a compatible consolidant, samples were taken of all the pigments as well as the plaster. Examination of the pigment samples was made by FTIR, Raman, and XRF, which revealed the presence of calcium carbonate in every sample and hematite in the red pigment, which implies the use of red earth. The results showed peaks for green earth, azurite for blue [fig. 9], and limewash for white color.<sup>6</sup>

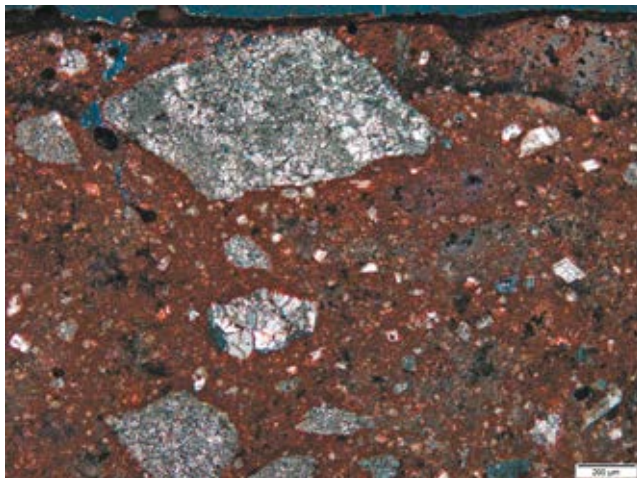
10.  
Thin section of *intonaco*,  
treated with Alizarin  
Red S dye, differentiating  
dolomite from calcite,  
photo by Eva Marija Fras,  
2020

Extraction of the binder was performed, which resulted in calcium carbonate. A thin section of the *intonaco* was stained with Alizarin Red S dye to differentiate dolomite from calcite. The aggregate stayed intact, indicating a dolomite substrate [fig. 10].

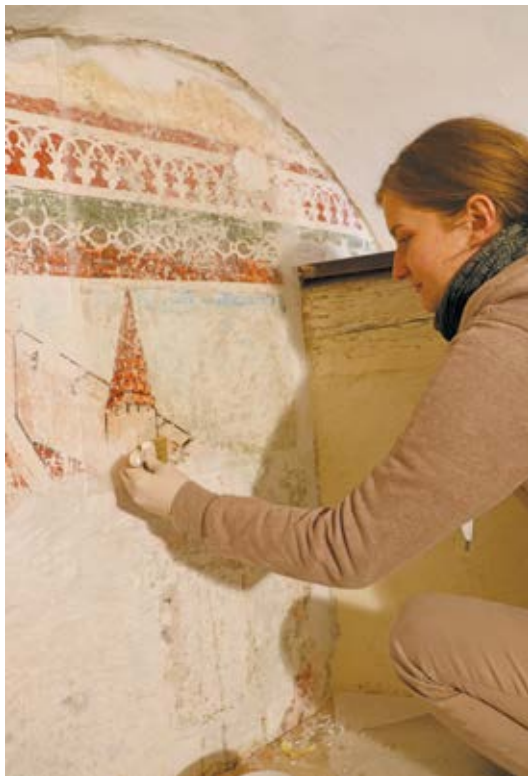
11.  
Application of nanolime by brush over  
Japanese paper, photo by Eva Marija  
Fras, 2020

Nanorestore was used in a solution with 2-propanol in ratio 1:1. It was applied in one generous layer by brush over one coating of Japanese paper to the paint layer on the entire northern wall [fig. 11]. The consolidant was left on the wall until the solvent had evaporated and the Japanese paper fell off. The stability of the paint layer was tested before and after consolidation with wetted cotton swabs. On all pigments there was a significant enhancement of the cohesive and adhesive bonds. Consolidation on areas with blue pigment azurite, which consists of larger particles, was not yet optimal. On those areas, the second application of Nanorestore took place, which resulted in substantial stabilization of the paint layer. After the treatment there was no white veil or other changes of the paint layer visible.

CaLoSil was used on the lower parts of the wall, where the plaster was broken and cracked. It was applied in one generous layer by brush over

one coating of Japanese paper. As with Nanorestore, CaLoSil was left on the wall until the solvent had evaporated and the Japanese paper fell off. The broken parts of *intonaco* and the plaster underneath it were stabilized but required another treatment with the consolidant. After two applications, the binding of the broken areas of the lower parts of the wall was optimally restored.

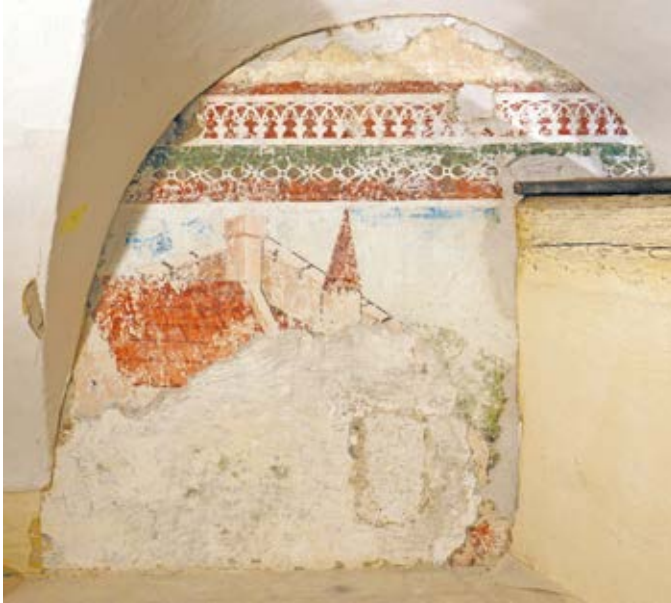
12.  
The painting above the  
choir in Mala Ligojna,  
photo by Eva Marija  
Fras, 2020

The painting in Mala Ligojna is preserved fragmentarily in large areas. The area under the choir is mostly lost, and no specific object can be identified. On the opposite side, above the choir, is an almost completely preserved part of a castle with hills and a blue sky [fig. 12]. Continuing towards the central area of the northern wall, between the choir and the first pilaster in the nave, are fragments of a small hut in the background that could be interpreted as an animal shelter. In the foreground are fragments of people's clothing. Lower down, we can distinguish some parts of horses' legs.

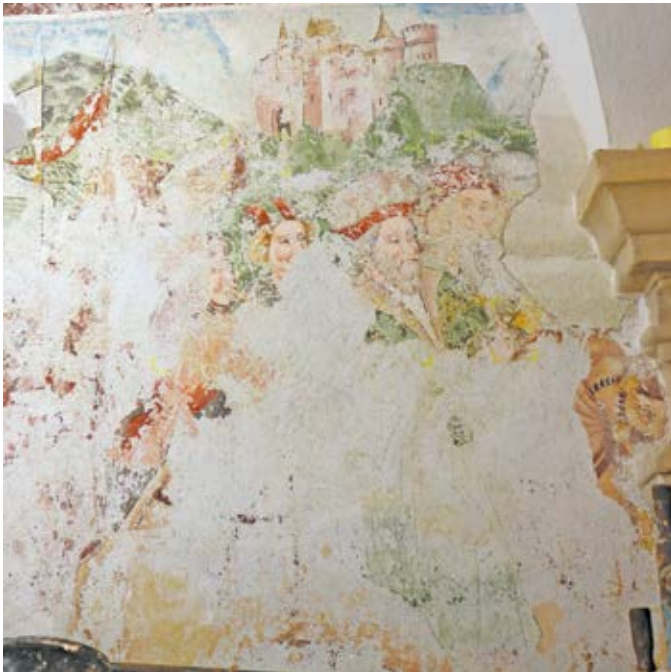
13.  
Central part with  
figures and a part of  
the horse on the right  
by the pilaster, photo  
by Eva Marija Fras,  
2020

In the foreground of the lower part, at least four people are distinguishable. We can immediately identify one of the kings because he is wearing a crown and green royal brocades. The other people are younger; therefore, we can assume they are the kings' escort, the horsemen and musicians. They are all preserved only in the upper part, the head area. By the right pilaster is a very well-preserved head of a horse with a harness, which the king is riding [fig. 13].

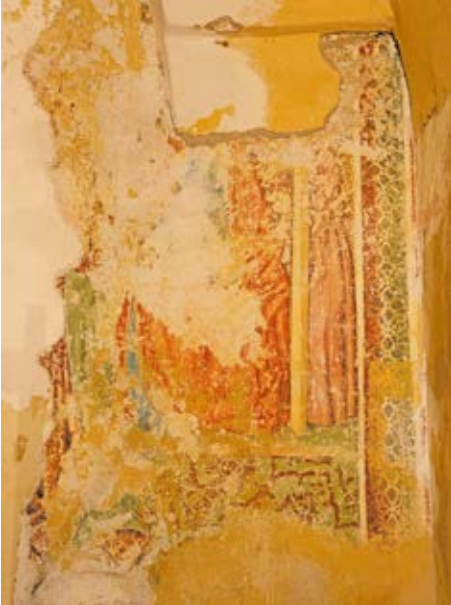
14.  
Scene on the right, Mary in blue and red clothing holding baby Jesus (only a white silhouette), photo by Eva Marija Fras, 2020

On the right part of the wall, the painting was partly damaged by the Baroque window, and the painted blue sky continues from the left part. On the right, by the window, we can distinguish large red and blue drapery, which was commonly used for Mary's clothing [fig. 14]. By the shape of the drapery, we can follow her silhouette and conclude that her head

was unfortunately covered by the secondary ceiling. In her lap, almost all the paint layer is lost, but there is a visible silhouette of the baby Jesus. He stretches out his right hand to one of the kings, who is bowing before him, offering a gift. The king is preserved only in small fragments on the left, as the rest was destroyed by the installation of the Baroque window (see fig. 13).

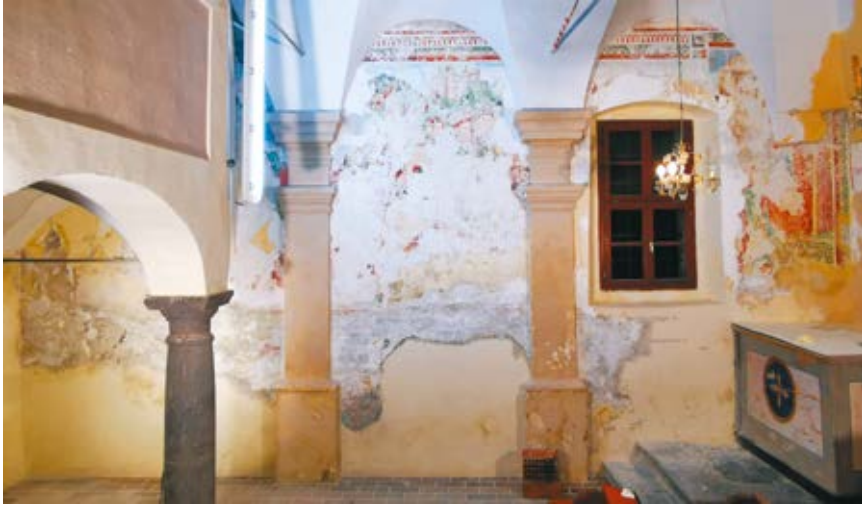
15. Northern wall in the Church of St. Leonard in Mala Ligojna, after uncovering, photo by Eva Marija Fras, 2020

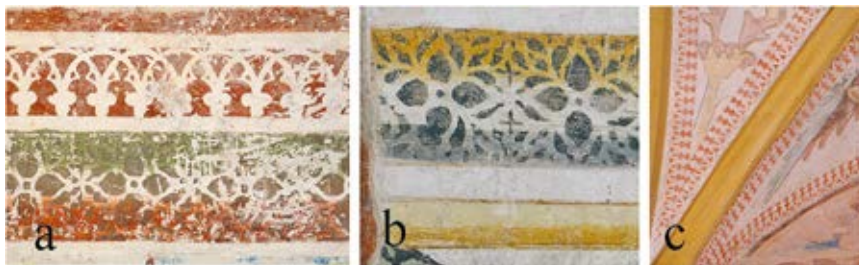
16.

A. Border pattern in Mala Ligojna; B. Border pattern in Vrzenec – Master Leonard; C. Border pattern in Krtina – Master Leonard, photos by Eva Marija Fras, 2020

The border pattern is composed of a wide red line as the external borderline and two bands of border patterns below. The first is a homogeneous red geometrical stencil pattern on a white background and the second is a black floral stencil pattern on a green, white, and red horizontally oriented background [fig. 16 A].

Specific patterns are known to be used by individual artists and/or their apprentices. Similar border patterns to those in Mala Ligojna were used by Master Leonard in the Church of St. Kancijan in Vrzdenc [fig. 16 B] and in the Church of St. Leonard in Krtina [fig. 16 C].

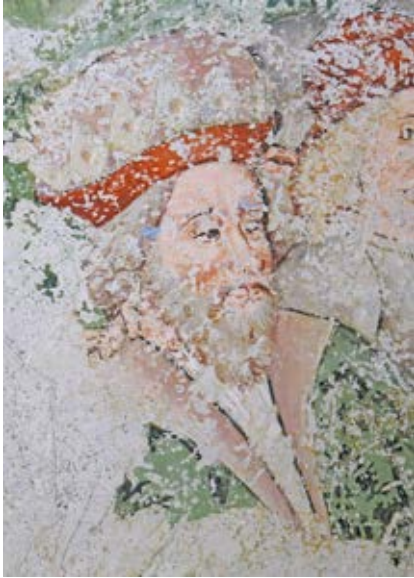
19.  
King with royal drapery, detail, photo by Eva Marija Fras, 2020

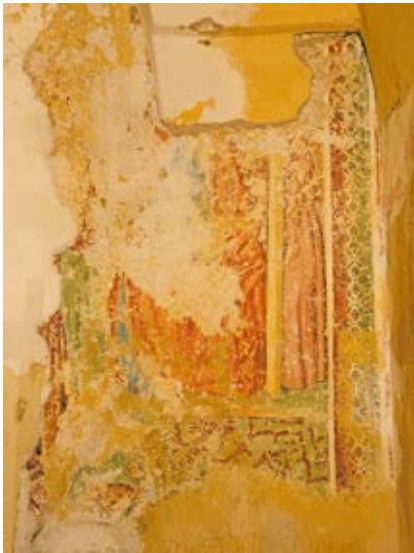
21.  
Scene with Mary holding baby Jesus, with a brocade pattern underneath, photo by Eva Marija Fras, 2020

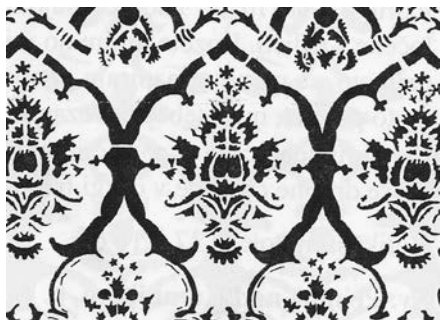
23.  
Textile pattern used by Master Bolfgang and his apprentices, drawing taken from: Alenka Vodnik, *Tekstilni vzorci v srednjeveškem stenskem slikarstvu na Slovenskem*, 1998, 149

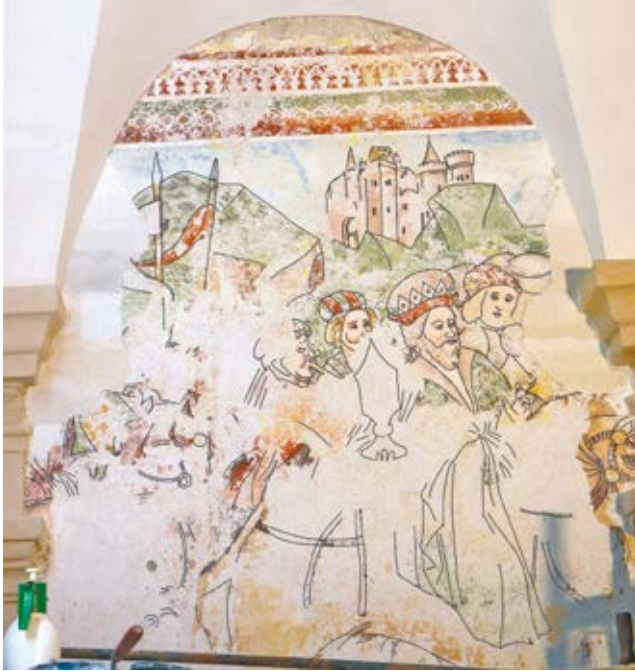
In the process of documentation, a linear reconstruction based on incisions took place [fig. 24]. Recognizable lines and shapes were added and compared to Master E.S.'s engravings. A close match was found to his copperplate Nr. 27 [figs. 25, 26]. The template mirrored vertically shows the same basic positions of main persons and architecture. This template is the possible guideline for the motif where a king pays homage to baby Jesus.

24.  
Central part of the wall  
with emphasized lines and  
incisions, made by Eva  
Marija Fras, 2021

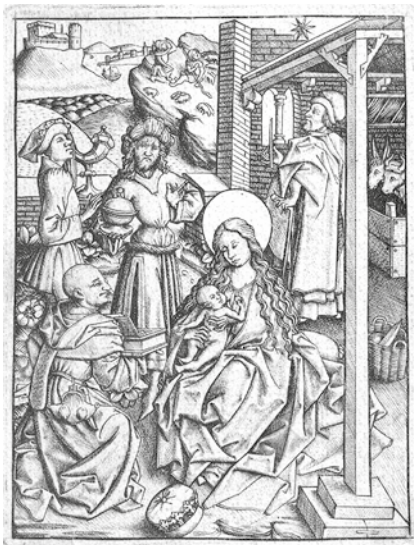
25.  
Master E.S., copperplate No. 27, image taken  
from: Janez Höfler, *Der Meister E.s.: Ein Kapitel  
europäischer Kunst Des 15. Jahrhunderts*, 2007

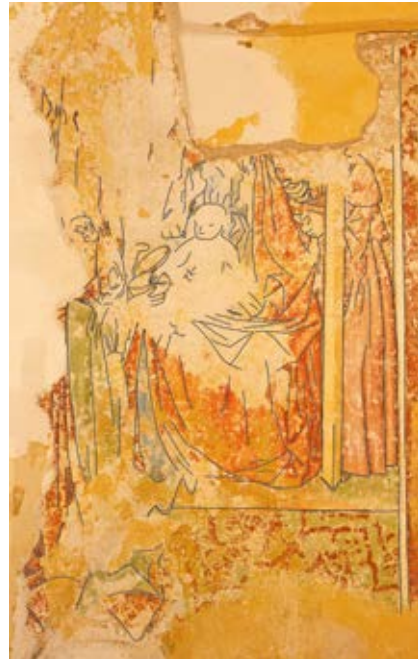
26.  
Emphasized lines and incisions, Mary holding baby  
Jesus, made by Eva Marija Fras, 2021

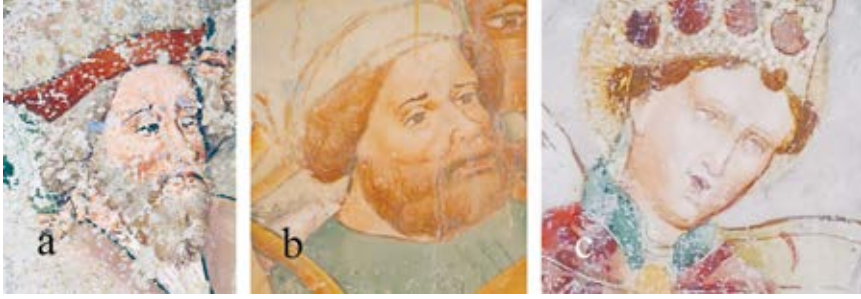
27.

A. Comparison of the king on the painting in Mala Ligojna; B. A man in Krtina – Master Leonard;  
C. St. Gregory in Mirna – Master Bolfgang, photos by Eva Marija Fras, 2020

The qualities of faces can be compared in paintings attributed to Master Bolfgang with those in Mala Ligojna, and his light, thin strokes with barely visible eyes, noses, and lips are recognized [fig. 27 C]. The skin tone is very subtle and gentle with no specific highlights. The formation of faces is often recognized as a feature of a single artist. It is significant that Master Bolfgang's proportions and lines don't match the dark tones around the eyes and a specific worried expression on the forehead on paintings in Krtina and in Mala Ligojna. In Bolfgang's paintings, the shape of the eyes and eyebrows is very subtle and gentle, while in Master Leonard's paintings, we can notice more humble, blissful expressions, with darker accents and more overall plasticity in the faces [fig. 27 B]. Comparing the two, we can see a very similar formation of faces in Master Leonard's paintings and in Mala Ligojna [figs. 27 A, B, 28].

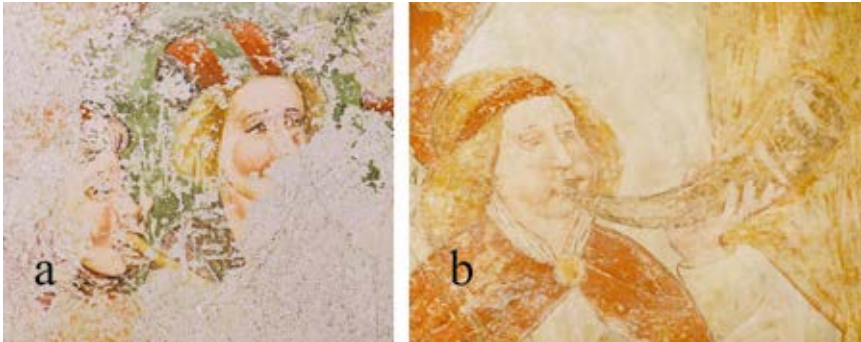
28.

A. Comparison of musicians in Mala Ligojna; B. A musician in Dole pri Krašcah – Master Leonard, photos by  
Eva Marija Fras, 2020

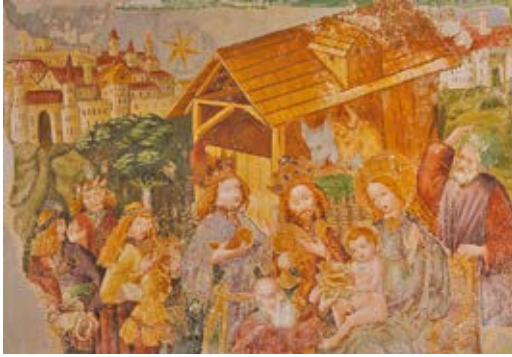
29.  
Adoration of the Magi in Mače, painted  
by the Master from Mače, photo by Eva  
Marija Fras, 2020

There are also a lot of similarities to the painting in Mače painted by the Master from Mače, Leonard's associate. [fig. 29]. The layout for the scene was formatted using graphical templates similar to those in Mala Ligojna [fig. 30]. The figures are very gentle, with soft transitions from dark to light. A closer look reveals that the faces show more similarities to those in the church in Mirna, painted by Master Bolfgang. This shows the influence of Master Bolfgang's heritage on his successor, the Master from Mače.

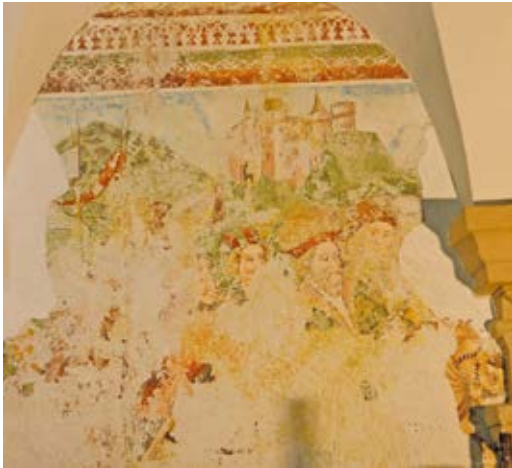
30.  
The painting in Mala Ligojna, central  
area, photo by Eva Marija Fras, 2020
