Wooden Mezzanine House in Užupis, Vilnius: Gains and Losses of the Restoration Process

——— The article presents an overview of the course of conservation work on the house at 52 Polocko Street – one of the most beautiful wooden houses in Vilnius – and its adaptation for the Museum of Urban Wooden Architecture. It describes the steps taken before the restoration of the building, including the strategic decision-making and fund-raising activity, as well as the search for the function to be served by the house. The article also reviews the applied research efforts, proposed solutions, and the analysis of issues faced and addressed in the process of the restoration and adaptation.

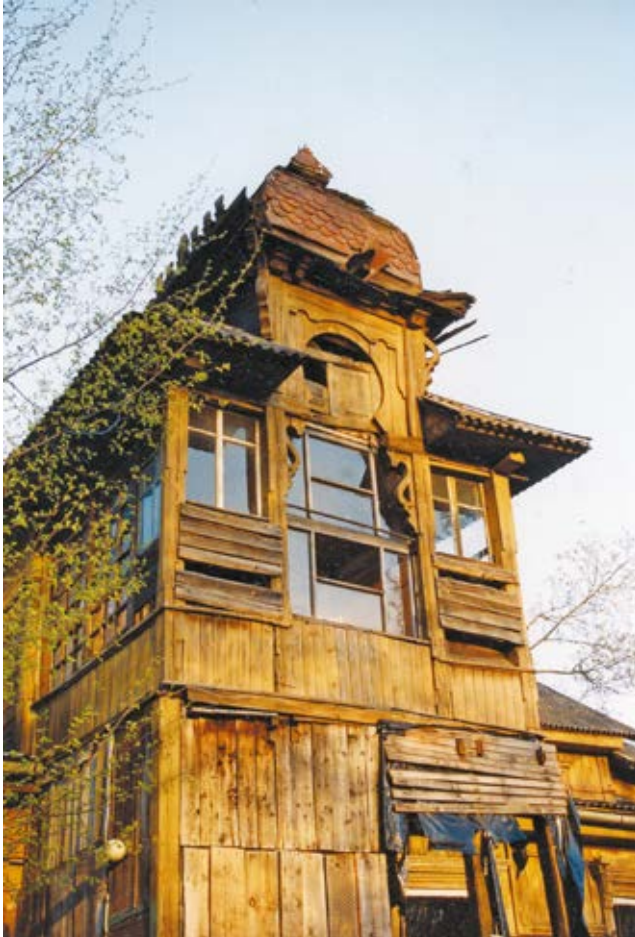
1.
Turret of the house at
19 Pavasario Street,
Vilnius. Photo by Giedrė
Filipavičienė, 2004

part of researchers, restorers, and carpenters [fig. 1]. Every single detail in these buildings is of great importance, as the incorrect replacement of any of them could result in irreversible loss of authenticity. However, replacements are unavoidable, as adaptation for contemporary needs necessitates certain engineering and technical changes to ensure the comfortable and safe use of these buildings.

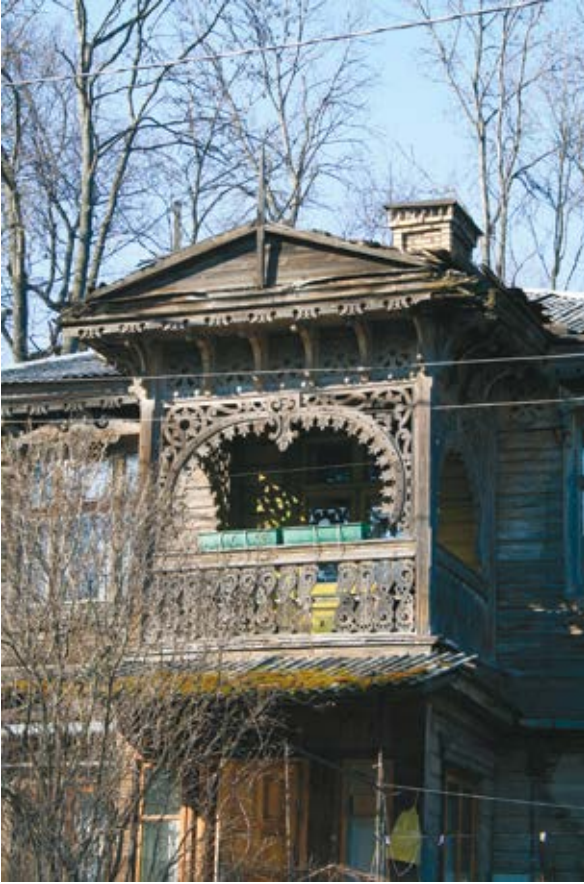
2 A.
Mezzanine of the house at
52 Polocko Street. Photo by
Giedrė Filipavičienė, 2007

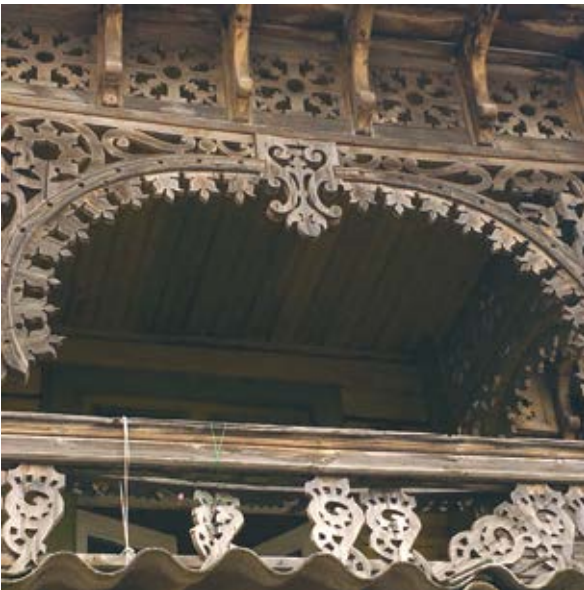
2 B.
A fragment of the facade of
the house at 52 Polocko Street.
Photo by Vincas Brezgys, 2017

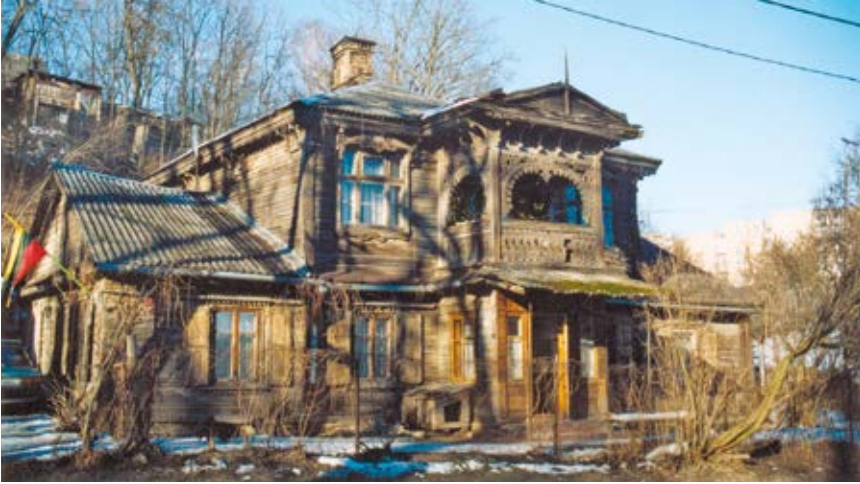
5.

After the inspection of the building and assessment of the house construction in 2006, it was concluded that the house was in poor condition, and the flats were small and cramped. There was no water supply or sewage networks, and heating was provided by gas-fired stoves. According to the residents, gas burners had been installed thirty years ago.⁶ Chimneys had not been cleaned and had cracks. The heating devices were in need of emergency work. The electrical wiring did not meet fire safety requirements.⁷ According to Racevičienė, the poor condition of the building was obvious

The house at 52 Polocko Street before restoration. Photo by Giedrė Filipavičienė, 2004

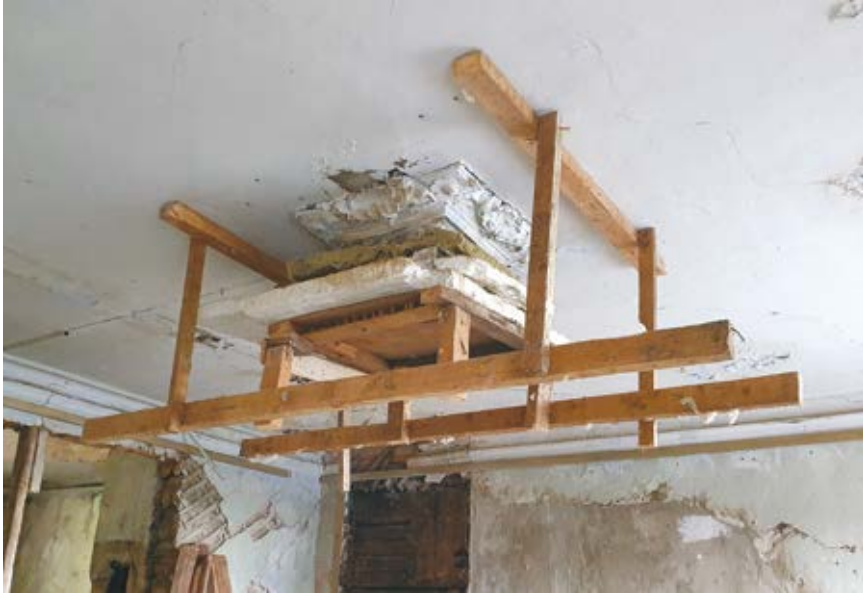
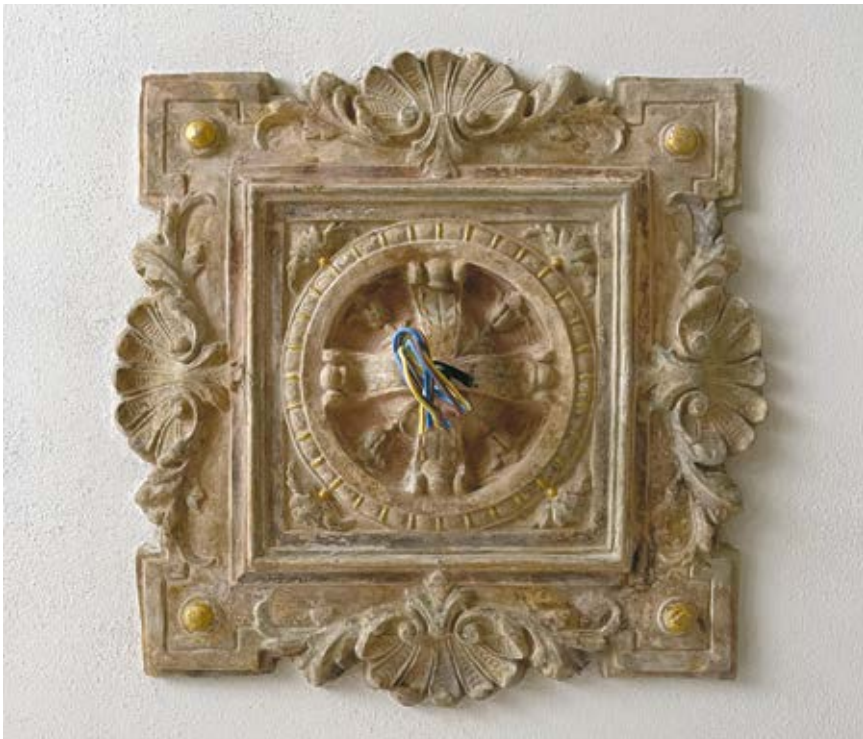
6 A.
Rosette in the room on the attic during restoration works. Photo by Giedrė Filipavičienė, 2020

6 B.
Rosette in the room on the attic after restoration. Photo by Vilius Mateika, 2022

The rooms on the second floor were painted in light brown, and the ceiling moulding was highlighted in warm, gray-brown tones. In the center of the room, individual elements of a papier-mâché rosette were painted to simulate gilding [figs. 6 A, B].

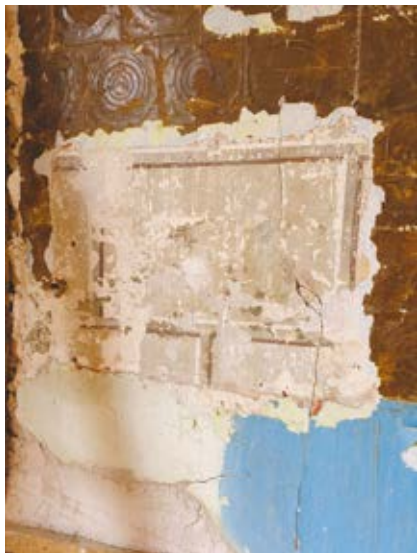
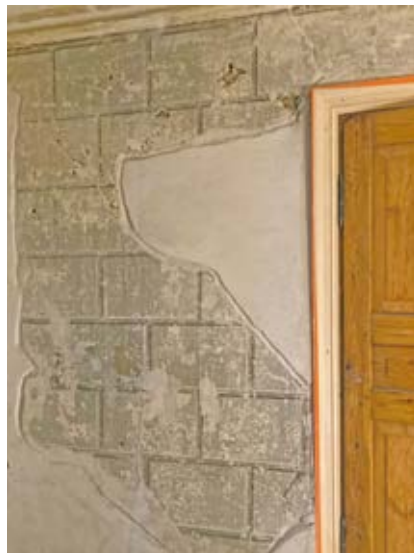
7 A.
A fragment of rustic décor in the room on the ground floor before restoration. Photo by Giedrė Filipavičienė, 2020

7 B.
A fragment of rustic décor shortly before completion of restoration works. Photo by Rūta Astasevičiūtė, 2021

Three main periods of decoration were identified. The earliest layer was presumed to be dated in the mid-nineteenth century and the later ones were dated to the late nineteenth and early twentieth centuries. In the earliest layer of the ground floor rooms, a vivid design featuring strips of rich blue, burgundy, brown, and gray was discovered, while the ceiling was decorated with a ribbon of grey umber¹⁹ against the background of two stripes in darker tones.²⁰ In the lobby of the ground floor, a faux-rustic finish was uncovered, which was a typical décor pattern used in the buildings of the period [figs. 7 A, B].

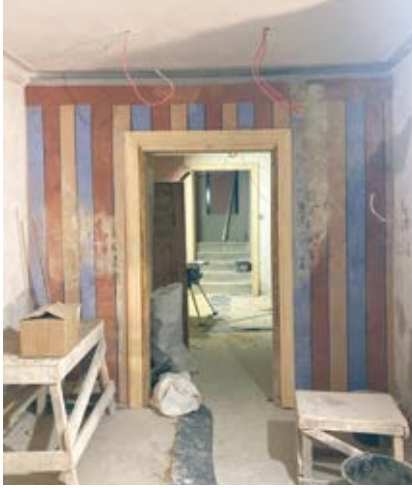
8 A. Polychrome decor of the lobby during restoration

8 B. Interior restoration drawing of the lobby

8 C. Interior restoration drawing of exposition–event hall. Photo and drawings by Rūta Astasevičiūtė, 2021

A similar color palette was also found in the décor layer from the second period. At the beginning of the twentieth century, the interior of the house was decorated with Modernist and Art Deco elements, imitating a striped fabric in rather bright colors.²¹ In the subsequent period, the walls were mostly covered in a single color or decorated with a roller and a modest frieze decoration.

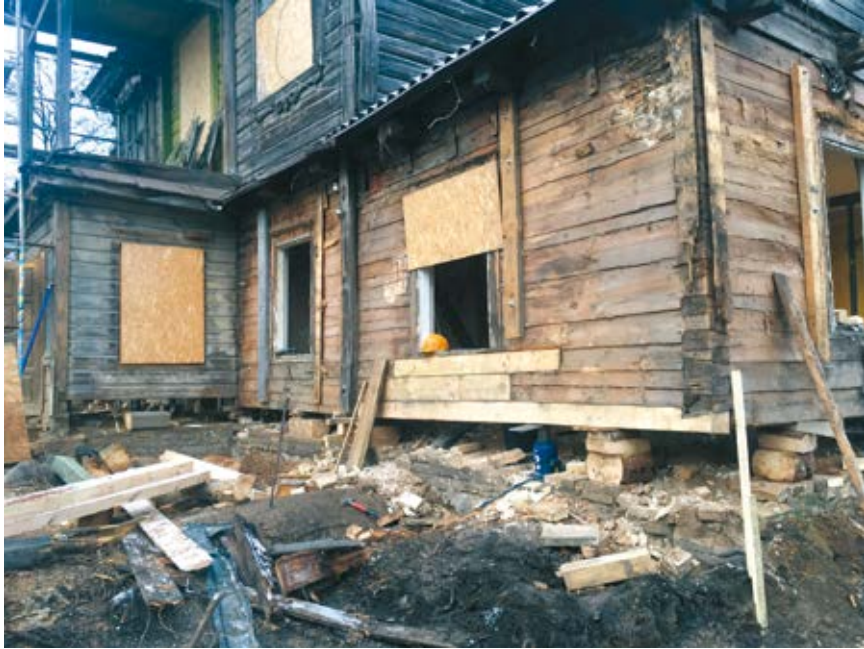
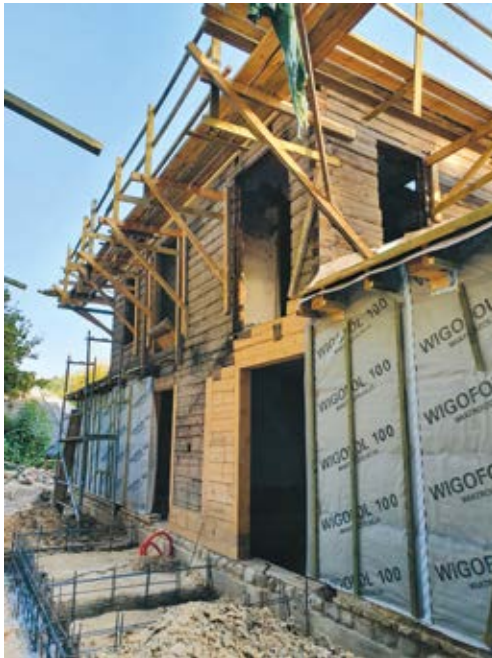
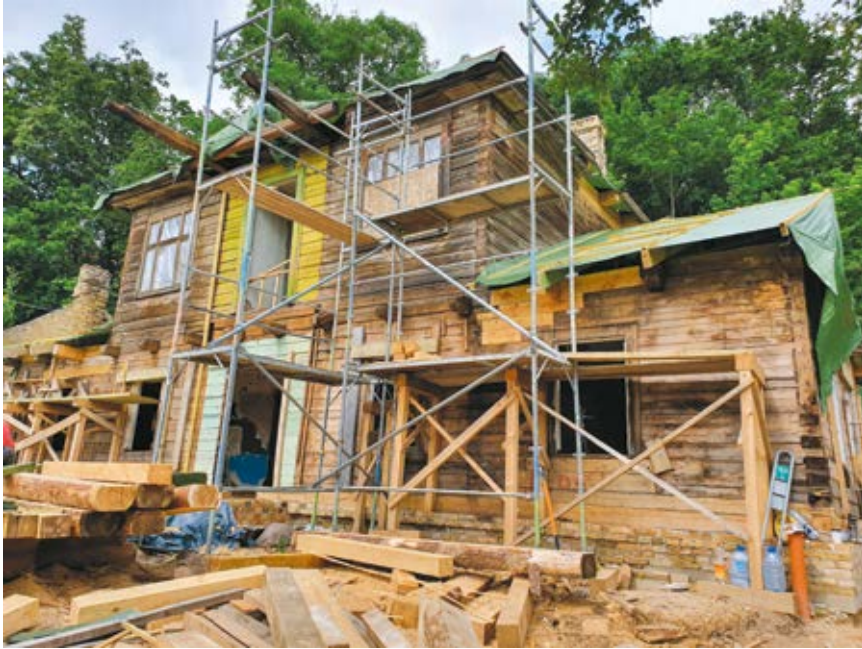
11 A, B.

The geometry of the building caused much debate. As a result of the deformations in the foundation, the walls of the house had started tilting to the south; the height of opposite corners differed by 60 cm. Attempts to straighten the house risked losing the interior polychrome décor. The log walls and the window and door openings were temporarily braced and reinforced to prevent the building from "spreading" and to maximize the

Restoration works: inserting new sections in the logs, conservation of the foundation. Photos by Rūta Astasevičiūtė and Giedrė Filipavičienė, 2020

protection of the polychromy. Following this preparatory work, the walls were raised using hydraulic jacks. After replacing fragments of the base of the wall, inserting new sections in the logs, and reinforcing the foundations, the deviations in the walls of the ground floor became insignificant. However, the walls of the first floor (mezzanine), reconstructed at the end of the nineteenth century, remained visibly inclined with a difference of about 7 cm vertically over the entire height of the building [figs. 11 A–C].

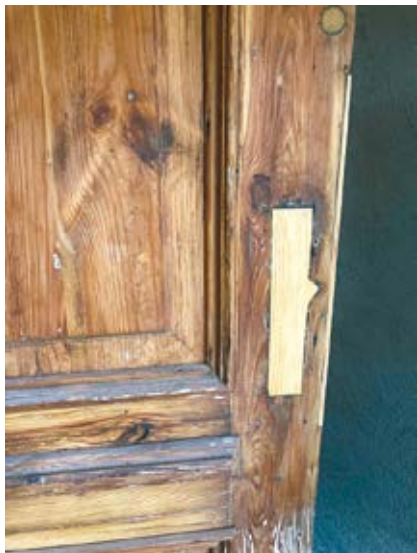
13.
A fragment of the authentic doors during restoration.
Photo by Rūta Astasevičiūtė, 2021

During the restoration, special attention was paid to the treatment of authentic elements such as windows, doors, and metal fittings [fig. 13].

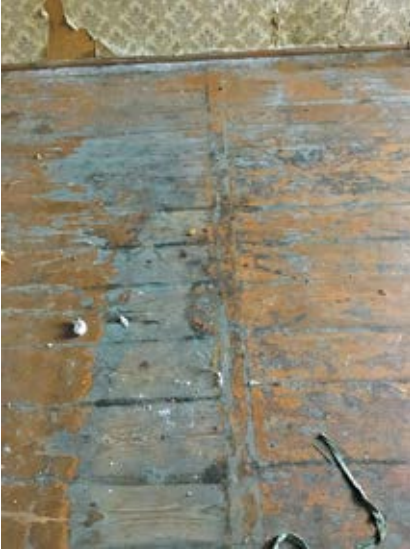
14 A.
A fragment of the authentic flooring before restoration. Photo by Vincas Brezgys, 2017

14 B.
A fragment of the authentic flooring during restoration. Photo by Giedrė Filipavičienė, 2021

Some of the original façade clapboards were retrieved and used for finishing the façade. The façade woodcarvings were carefully restored, and the missing segments were replaced with new ones. The floorboards on the first floor were dismantled and the paint residue was cleaned away. It was decided not to patch the cracks and nail holes. The boards were reassembled in the same order as they were dismantled, using floorboards from other rooms where necessary [figs. 14 A, B].

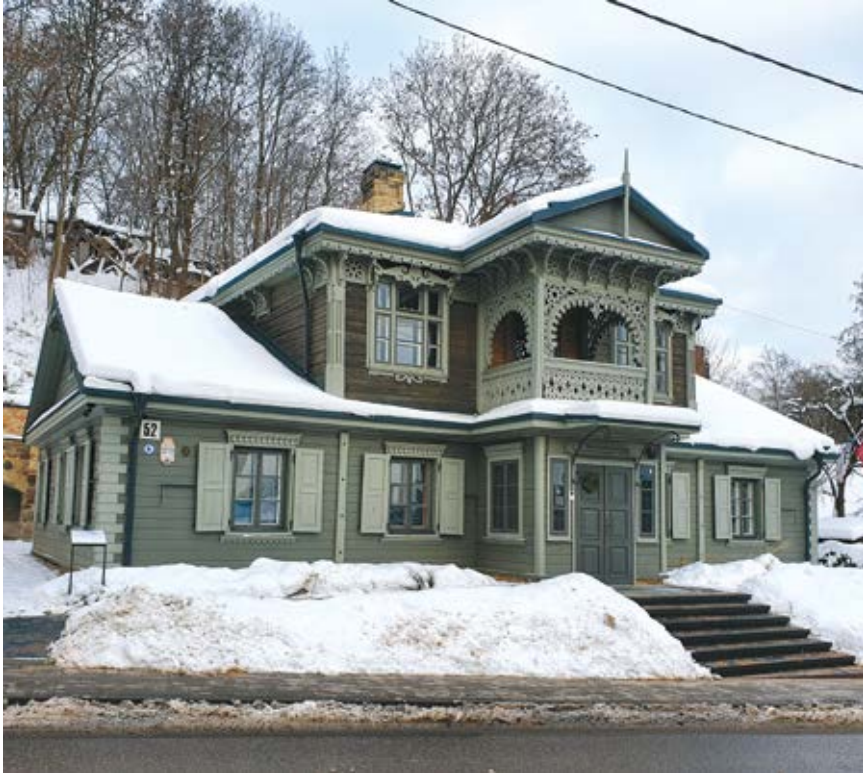
15.

The House at 52 Polocko street after completion of restoration works. Photo by Giedrė Filipavičienė, 2022
